CULTURAL LANDSCAPE REPORT

the **RICHARDSON OLMSTED COMPLEX** *Buffalo, NY*

October 2008

Heritage Landscapes
Preservation Landscape Architects & Planners

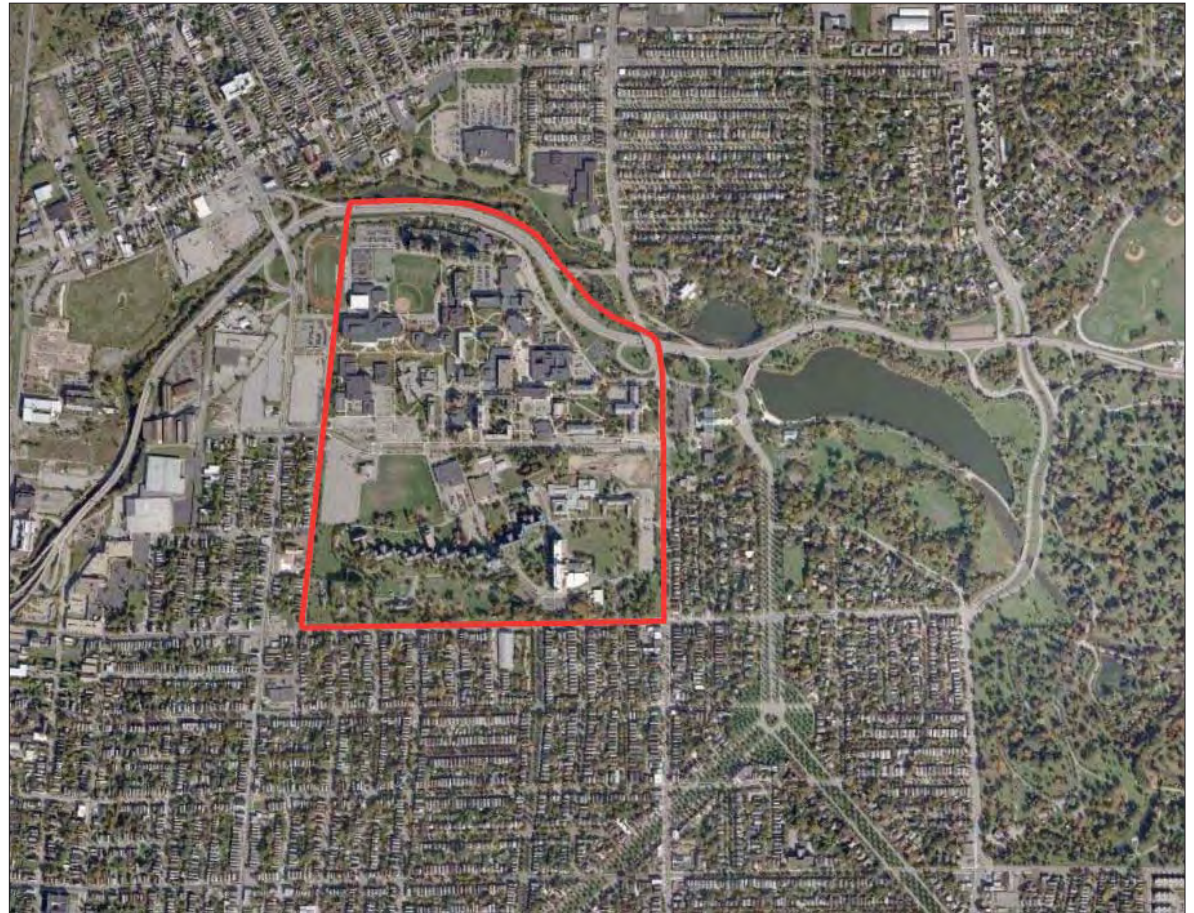
Figure I.1. A 2008 aerial photograph shows the former boundary of the Buffalo State Insane Asylum. The asylum is sited along the west edge of the Olmsted Crescent and is one of many Olmsted Vaux and Company designed landscapes in Buffalo. Image Courtesy Microsoft LiveMap. (R-BRO-MicrosoftAerial-2008.jpg)

The Richardson Olmsted Complex is located at the west edge of an area known as the Olmsted Crescent. Several of Buffalo's historical and cultural attractions are located within this crescent-shaped area, including a number of landscapes designed by Olmsted and Vaux, such as Delaware Park and Forest Lawn Cemetery. (See Figure I.1). The asylum grounds, together with the adjacent park lands, created a green swath of open spaces north of the city center.

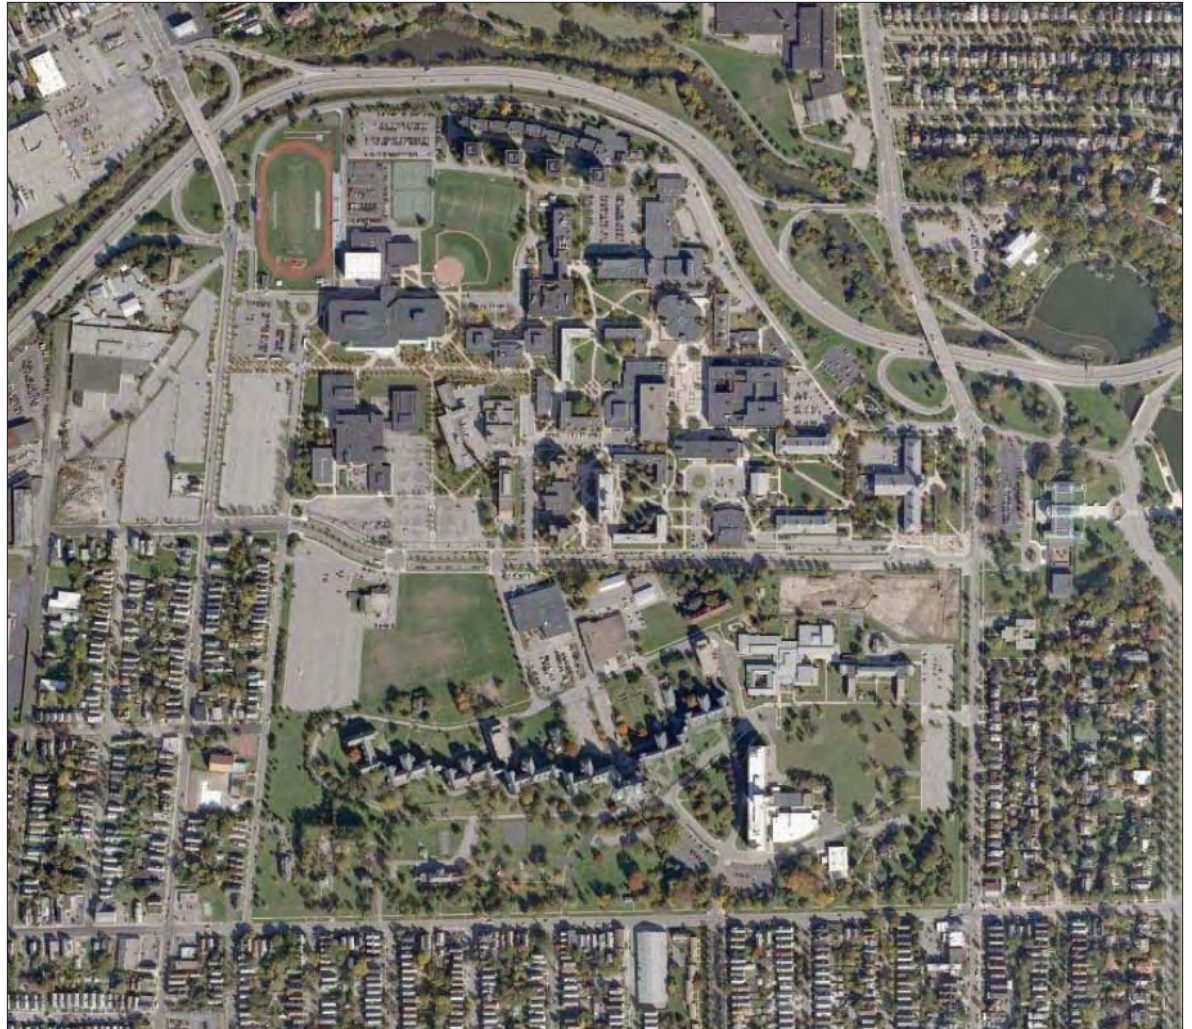
Figure I.3. A detailed aerial view of the former Buffalo State Insane Asylum, now known as the Buffalo Psychiatric Center. The property continues to serve as a mental health facility, though the context and surroundings have changed. Courtesy Microsoft LiveMap. (R-BRO-MicrosoftAerial-zoom-2008.jpg)

has decreased through the loss of agricultural lands for the development of the adjacent Buffalo State College to the north. (See Figure I.3). Today the property is bounded by Rockwell Road to the north, Elmwood Avenue to the east, Forest Avenue to the south, and Rees Street to the west. The remaining grounds exhibit remnants of the historical Olmsted and Vaux landscape, but exhibit change through the addition of new buildings, construction of parking lots, and decline and removal of vegetation. As planning and projects proceed for the continued use of the property, the value of the Richardson Olmsted Complex cultural landscape should be respected and preserved.

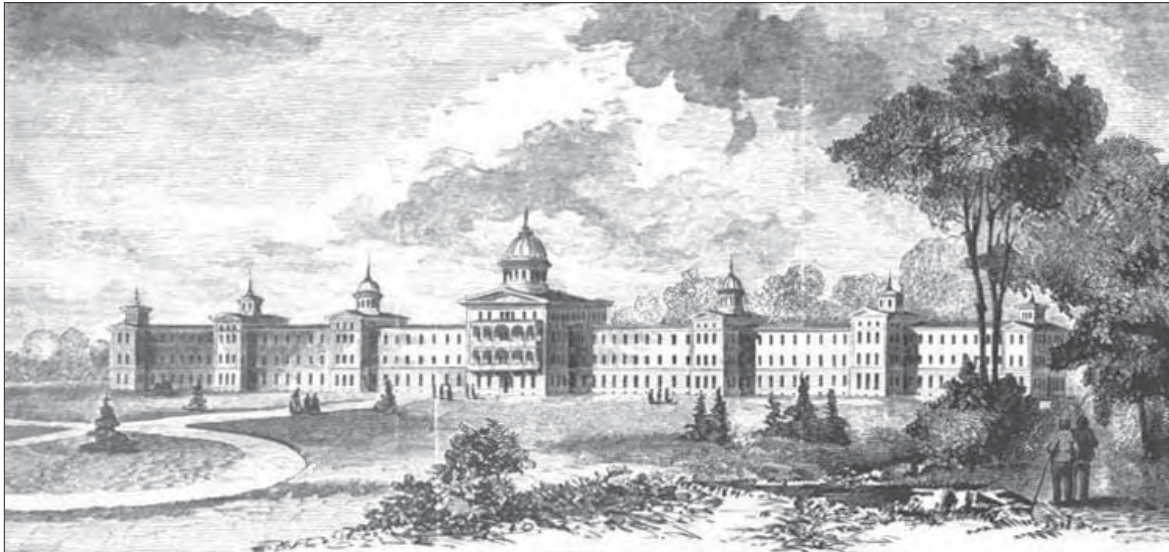
Figure II.4. “Plate III: Elevation of a Hospital on the Linear Plan” from Kirkbride’s book. Image courtesy of Google. (R-BRO-Kirkbride-Book-Engraving-2.jpg)

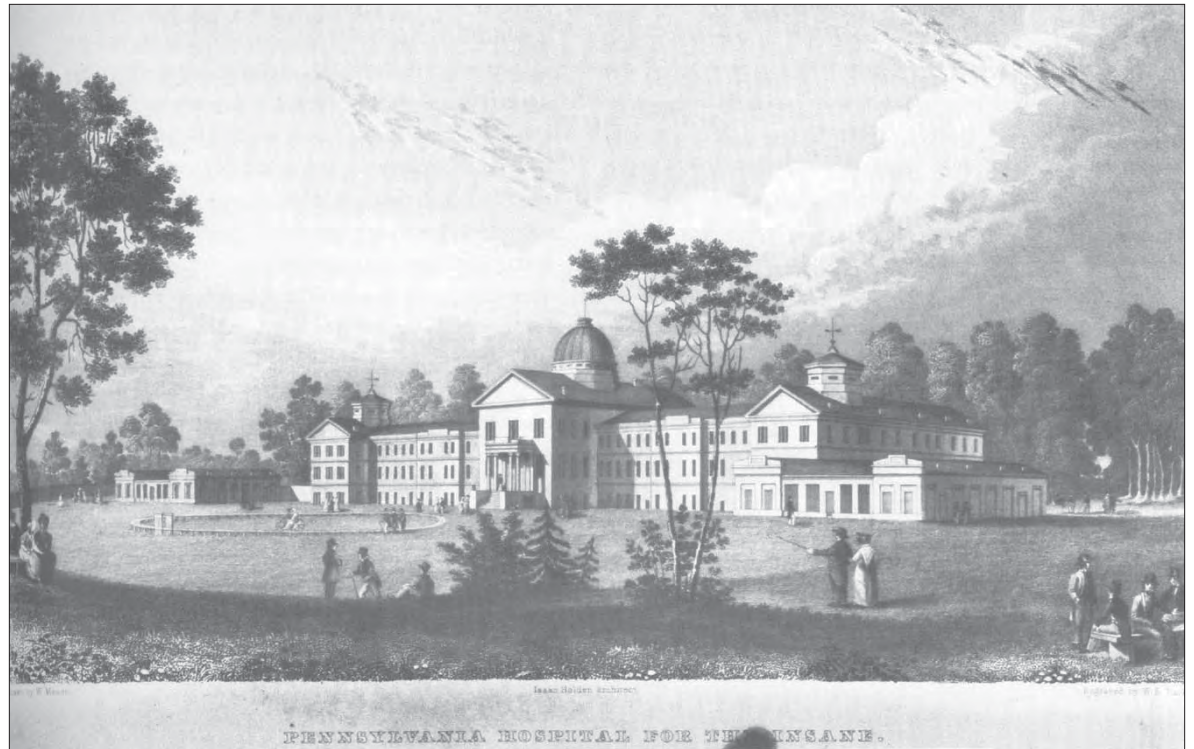
Figure II.5. “**Pennsylvania Hospital for the Insane, Isaac Holden, Architect**” was the first insane asylum building to exemplify Kirkbride's theories. Image reproduced from Yanni, 2007, 39. (R-BRO-PennHospital-Yanni.jpg)

Kirkbride's plan focused on both the character and quality of asylum architecture and the integrated relationship between building and landscape. Because of this important relationship between the asylum buildings and the landscape, greater emphasis began to be placed on creating a landscape of calmness that would aid in the recovery of mental health. The first Kirkbride-inspired asylum was the Pennsylvania Hospital for the Insane. Located on a pastoral site, with a simple round pool on axis with the main building, the open landscape of simple, gently rolling lawns and clusters of plantings embodied the propositions of curative settings and healing landscapes. (See Figure II.5).

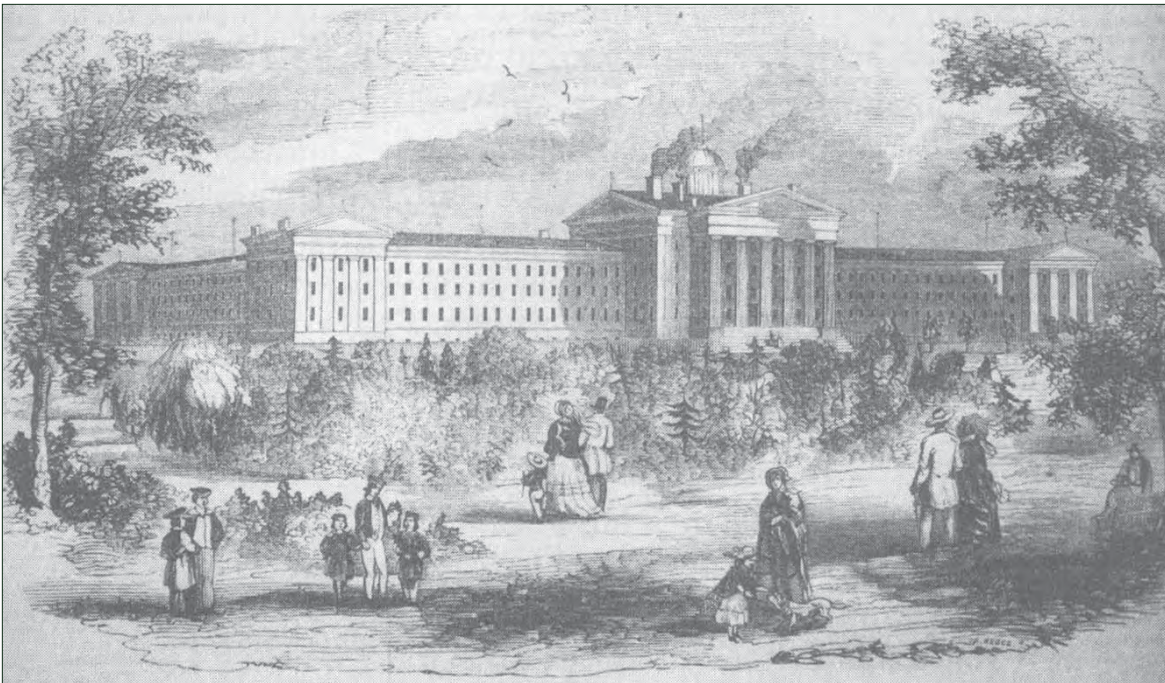
Figure II.7. **Landscape of New York State Asylum in Utica, New York, designed by Andrew Jackson Downing, 1842.** Image reproduced from Schuyler, 1996, 79. (R-BRO-NYSInsane-Utica-Downing.jpg)

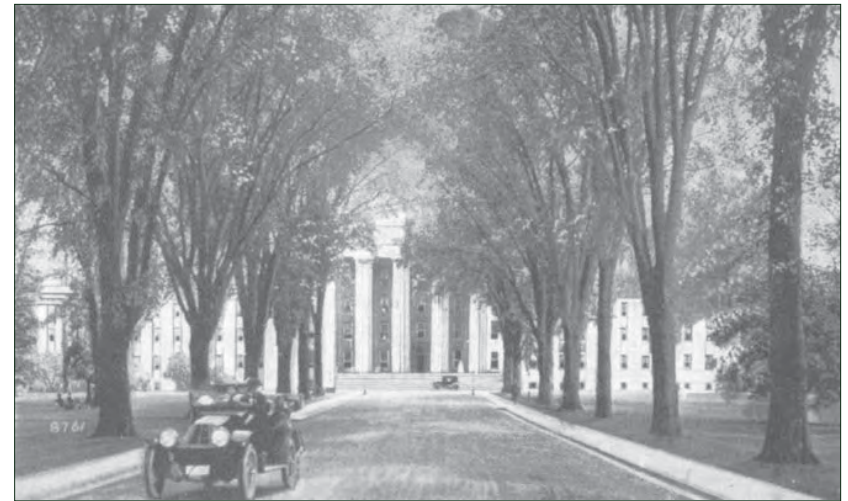
Figure II.8. Elm-lined entry drive at New York State Asylum in Utica, designed by A.J... Downing. Image reproduced from Yanni, 2007, 44. (R-BRO-NYSinsane-Utica-EntryDrive-Downing.jpg)

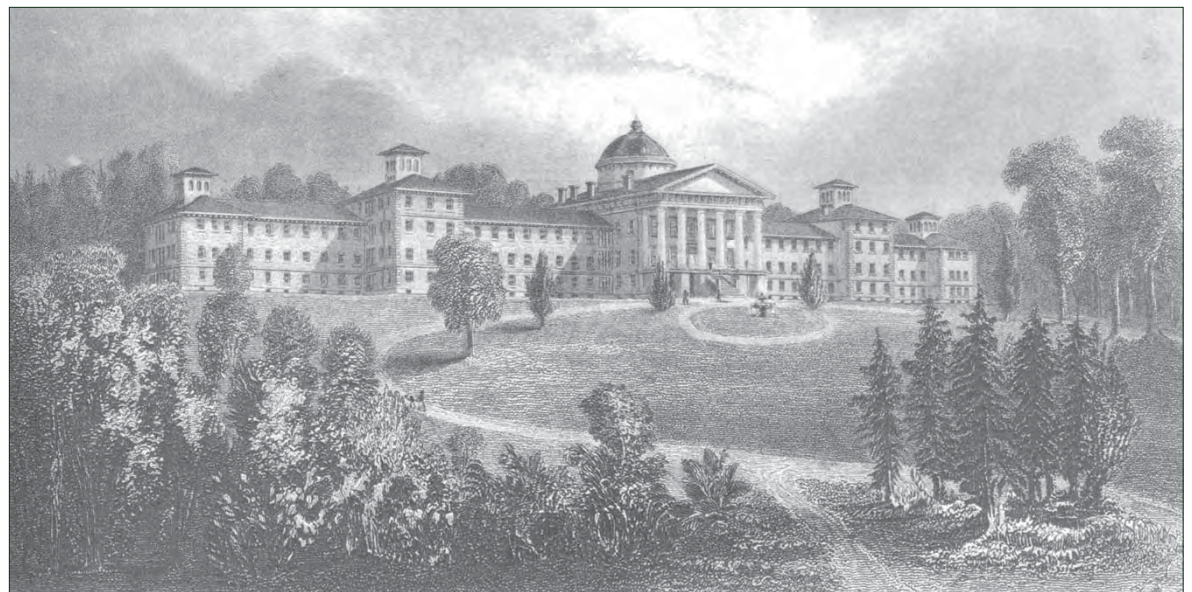
Figure II.9. Landscape and buildings of the New Jersey State Lunatic Asylum in Trenton, New Jersey, designed by Andrew Jackson Downing, 1848. Image reproduced from Schuyler, 1996, 81. (R-BRO-NJInsane-Downing.jpg)

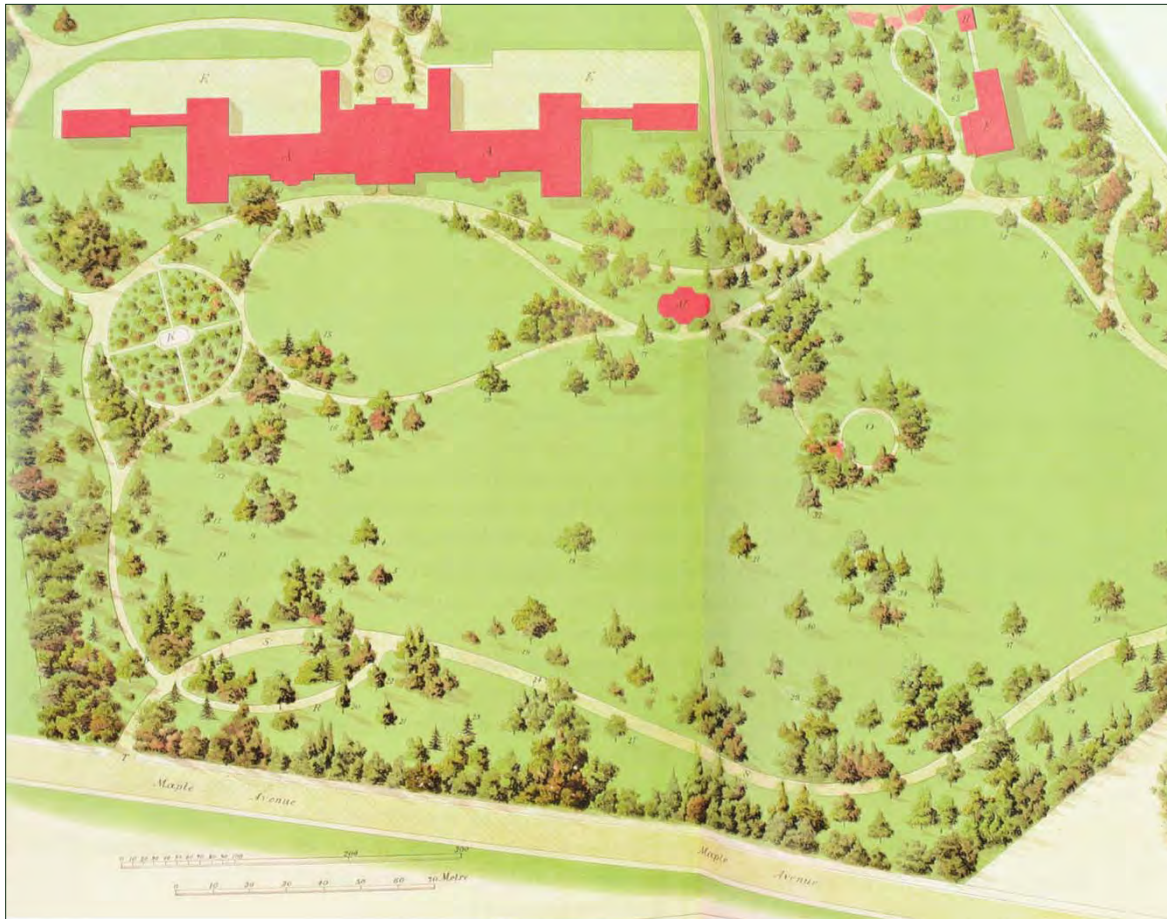
Figure II.13. Olmsted and Vaux plan for the Hartford Retreat for the Insane, now known as the Institute of Living, 1861. Image reproduced from Favretti, 2007, 57. (R-BRO-Olmsted-Vaux-HartfordRetreat-1861.jpg)

The Hartford Retreat for the Insane was an early Olmsted, Vaux & Company insane asylum commissioned in 1860. The Retreat was founded in 1822 with a complex of buildings set on a 37-acre expanse of rough, low-lying wetland with overcrowded trees and plantings.²⁰ Olmsted and Vaux were hired to create a “therapeutic Arcadia” with “embellished grounds” under the direction of Dr. John Simpkins Butler, Superintendent.²¹ The resulting plan was Pastoral in character with an open interior graced with curving walks and drives, clustered plantings, large expanses of lawn, and a circular garden. Screens of naturalistic plantings were used around the property perimeter to define the edge. (See Figure II.13).

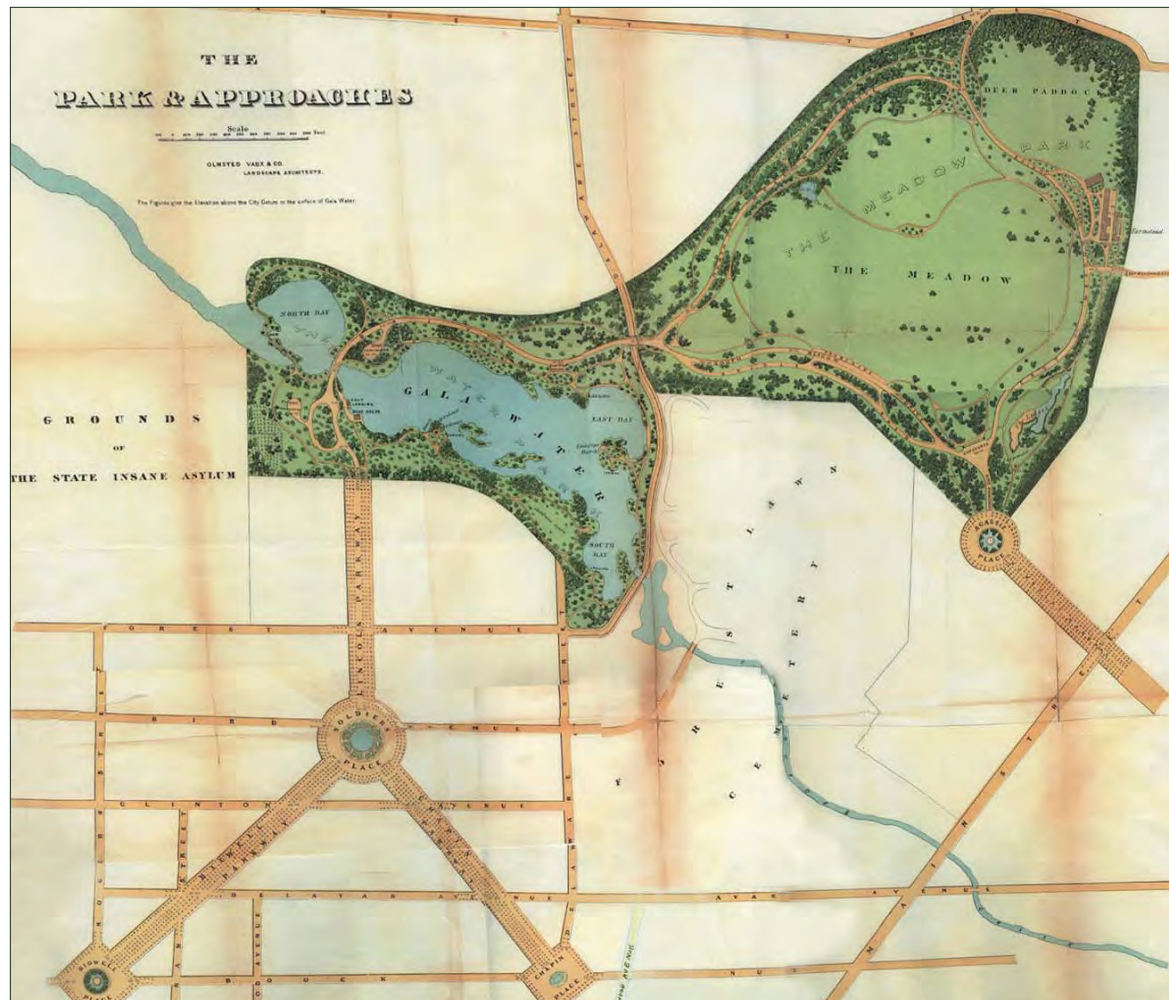
Figure III.2. “The Park & Approaches” by Olmsted, Vaux & Company, 1869. The plan illustrates the grounds of the future Buffalo State Insane Asylum in context with the Buffalo park and parkway system. Image courtesy Buffalo & Erie County Public Library. (R- BRO-BEC-ParkApproachesPlan-whole-1869.jpg)

The work of Olmsted and Vaux on the Buffalo park and parkway system was not only linked with their design of the grounds for the Buffalo State Insane Asylum, but it also likely influenced the selection of a project architect. While H. H. Richardson would eventually become a nationally renowned architect, in the late 1860s and early 1870s, he remained fairly unknown. However, Olmsted and Richardson had developed a friendship while both living and working in Staten Island, New York, and they came to collaborate on several projects. In 1868, Richardson was selected to design houses for Dorsheimer and another prominent citizen of Buffalo, Asher P. Nichols, likely a result of Olmsted’s professional relationship with Dorsheimer. By 1870, Richardson had prepared plans for several churches, and his reputation was beginning to grow. The following year, Olmsted, Vaux & Company was selected to design and lay out the grounds for the Buffalo State Insane Asylum and Richardson was secured as the architect for the asylum building.⁴ Olmsted, Vaux and Richardson worked together to create an impressive landscape that would not only contribute to the treatment of mentally ill, but also would serve as an iconic landscape for the city.

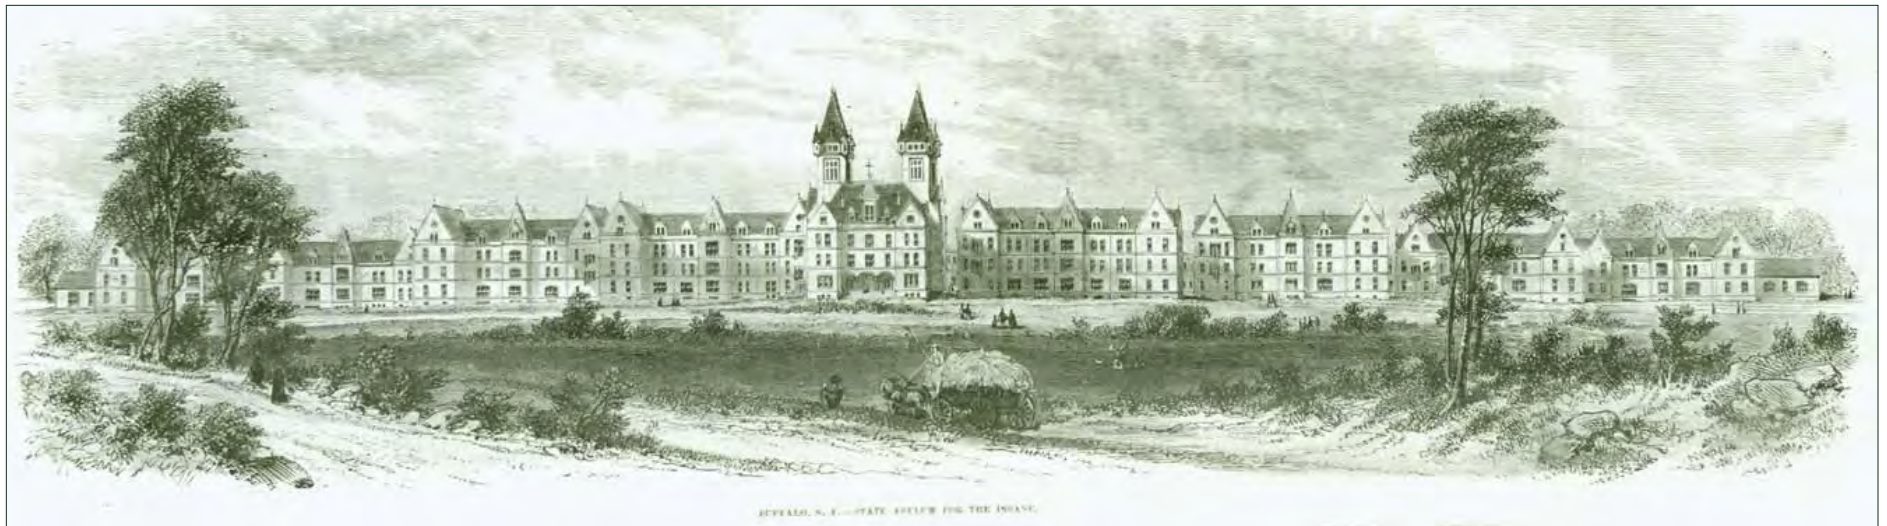
Figure III.3. **Buffalo State Insane Asylum, circa 1888.** The Olmsted and Vaux landscape design used the character of the land and the impressive architectural style to define an iconic, park-like landscape in northern Buffalo. Image courtesy Buffalo & Erie County Historical Society. (R-BRO-BHS01a.jpg)

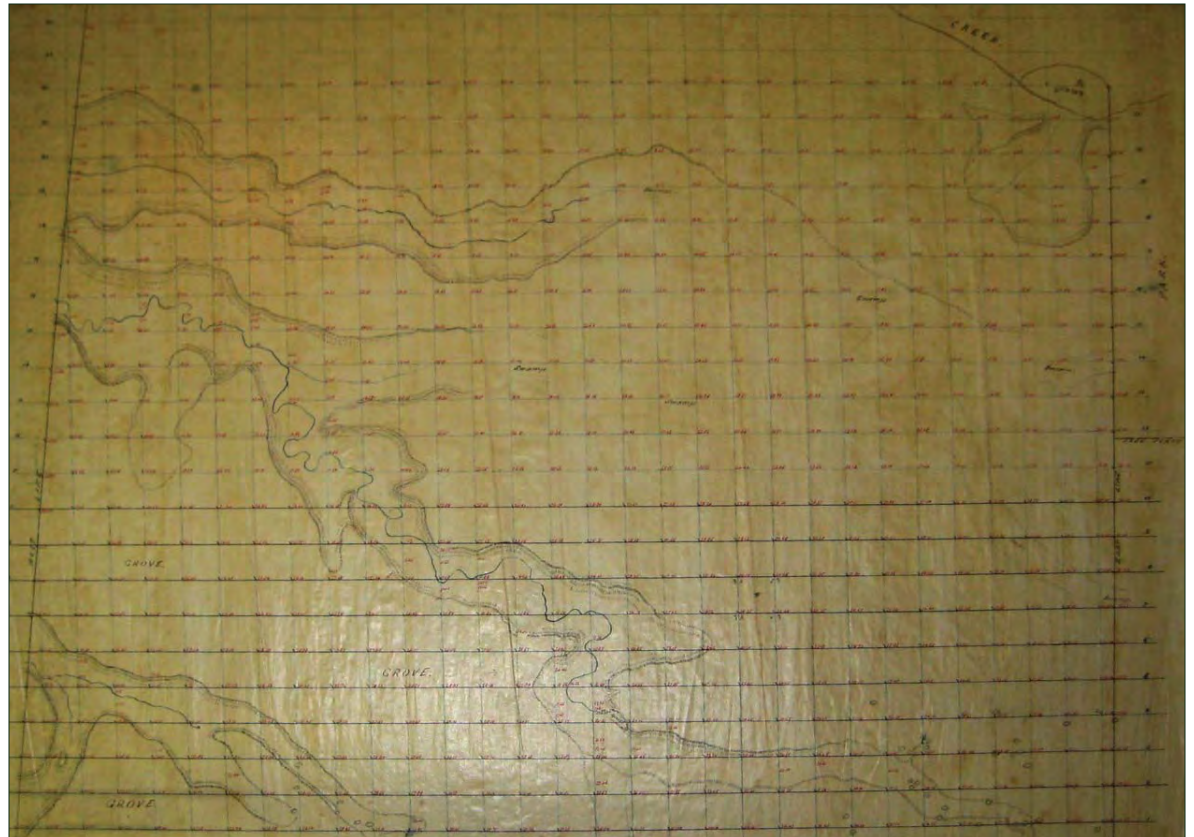
Figure III.4. **Untitled topographic survey, Olmsted, Vaux & Company, c.1871.** The natural condition of the future asylum grounds included several streams, ravines, and three tree groves in the southwest property corner. Image courtesy Frederick Law Olmsted National Historic Site. (R- BRO-FLO-1872-612-4-adj.jpg)

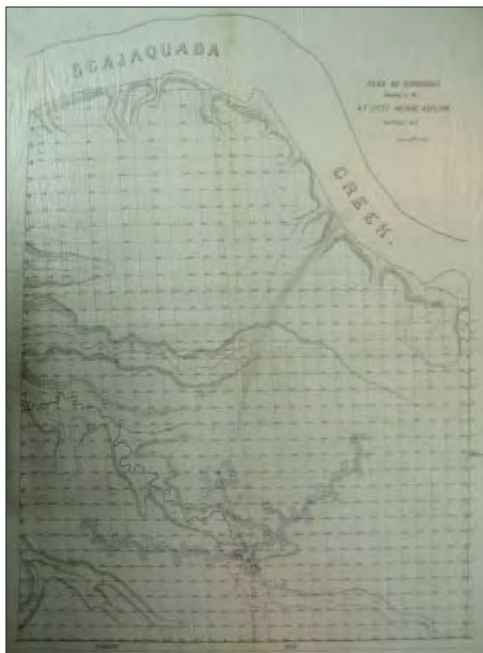
Figure III.6. “Plan of Grounds Belonging to the N.Y. State Insane Asylum, Buffalo, NY,” c. 1870. Note the angled alignment of the asylum building positioned over a ravine. Image Courtesy Buffalo Psychiatric Center. (R-BRO-FLO-1872-612-20)

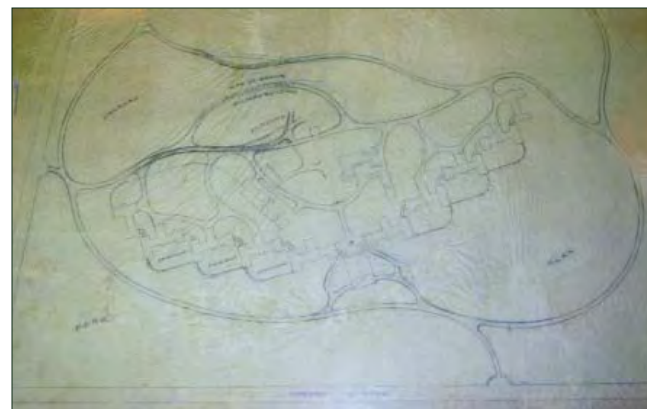
Figure III.7. Untitled sketch, Olmsted, Vaux & Company, circa 1870. The sketch shows preliminary concepts for the grounds with carriage drives, parks, an orchard, paddock and airing courts. Image Courtesy Buffalo Psychiatric Center. (R-BRO-FLO-1872-612-28F2.jpg)

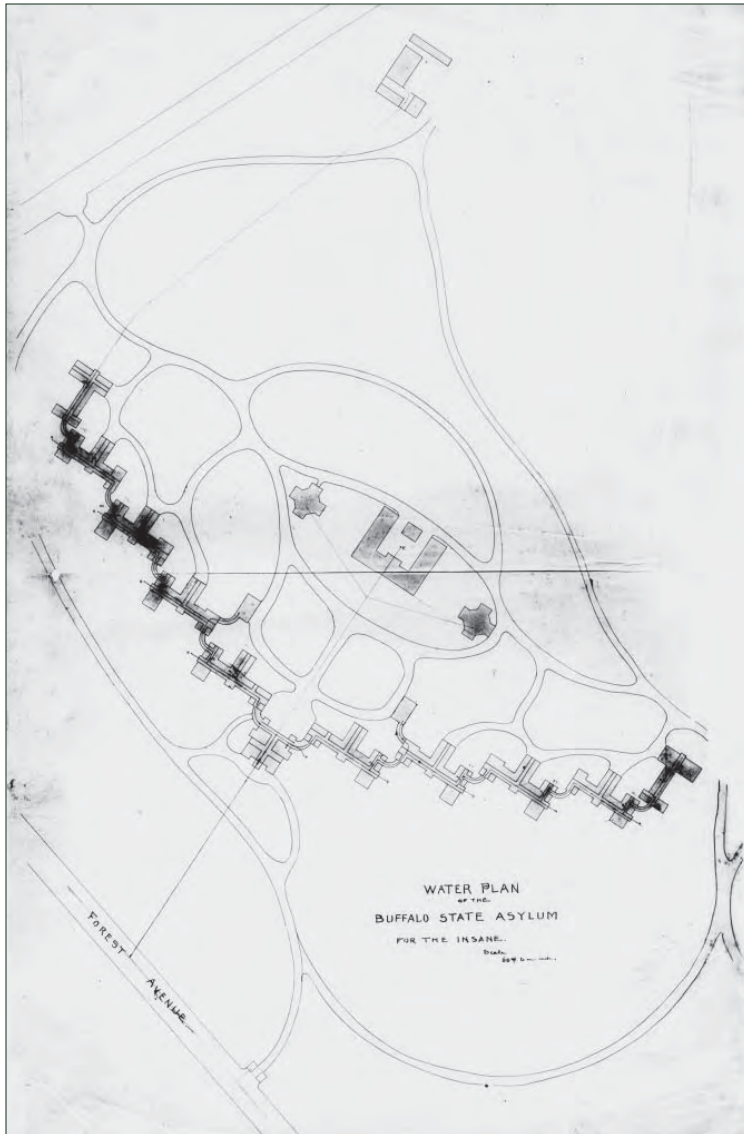
Figure III.9. “Water Plan of the Buffalo State Asylum for the Insane,” c.1870. The plan shows a more symmetrical organization of buildings and drives on axis with the main building complex. Image Courtesy Buffalo Psychiatric Center. (R-BRO-GCA-HHR-14_BLA_F4.jpg)

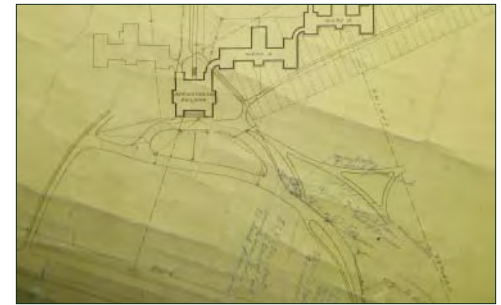
Figure III.12. **Detail of ‘Map of the Grounds of the State Asylum for the Insane.’** Drives were constructed according to the Olmsted and Vaux design. Image courtesy Buffalo Psychiatric Center. (R-BRO-BPC-1887-Utility-Layout-Annotated-390.jpg)

Additional grounds improvements were carried out during the late 1870s and early 1880s in accordance with the Olmsted and Vaux design. At the direction of Dr. James P. White, Asylum Superintendent, Olmsted provided more detailed plans for the design and layout of additional landscape features, including walks and vegetation.²² The planting plan submitted by Olmsted, “*Buffalo State Asylum for the Insane, Planting Map for Southeast Section of Grounds*,” refines the earlier preliminary sketches and shows a network of walks and masses of vegetation located in the southeast corner of the asylum property. (See Figure III.13). The walks parallel and cross the entry drive and curve through the open space. Walks are framed by vegetation and two drive segments -- the entry

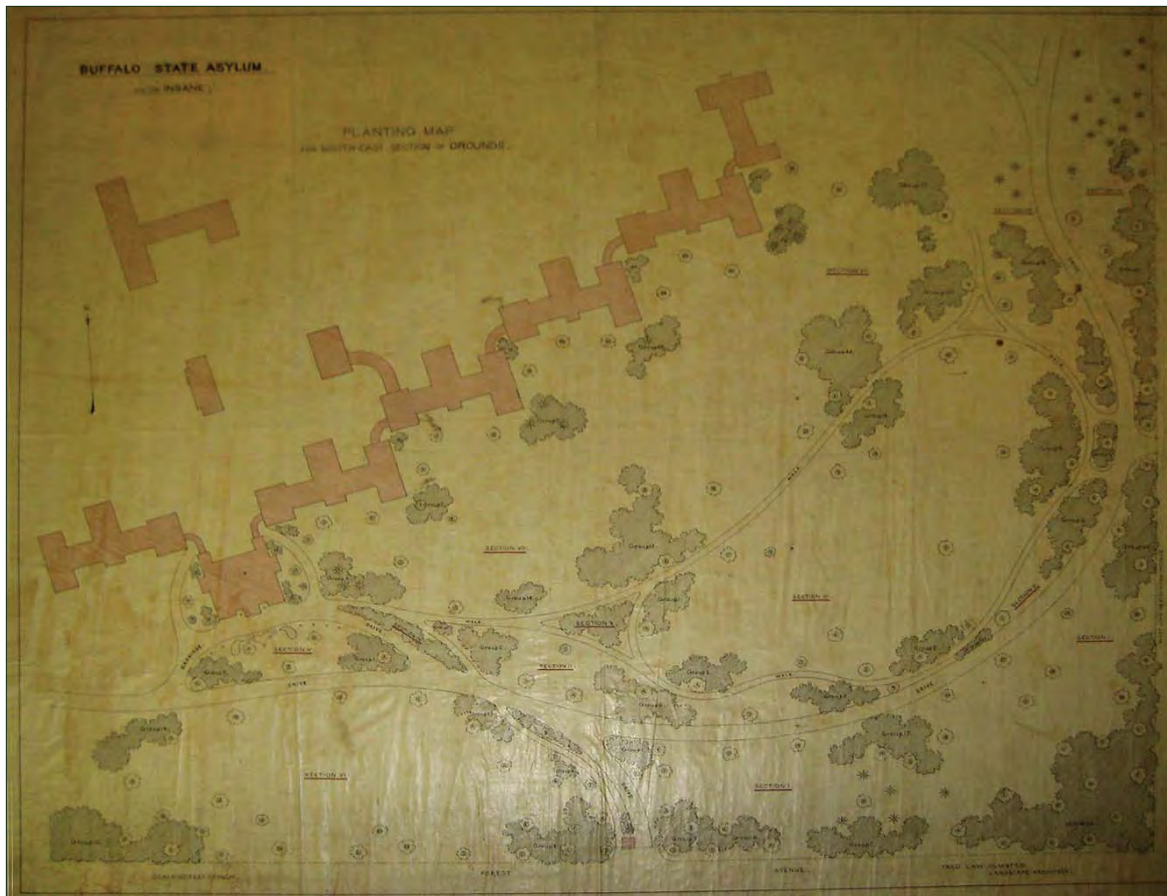
Figure III.13. 'Buffalo State Asylum for the Insane, Planting Map for Southeast Section of Grounds' from Olmsted, Vaux & Company. Tree and shrub massings interspersed through open lawn and bordering curvilinear drives and walks define a park-like character and frame views of the Richardson building complex. Image courtesy Frederick Law Olmsted National Historic Site. (R-BRO-FLO-1872-612-24.jpg)

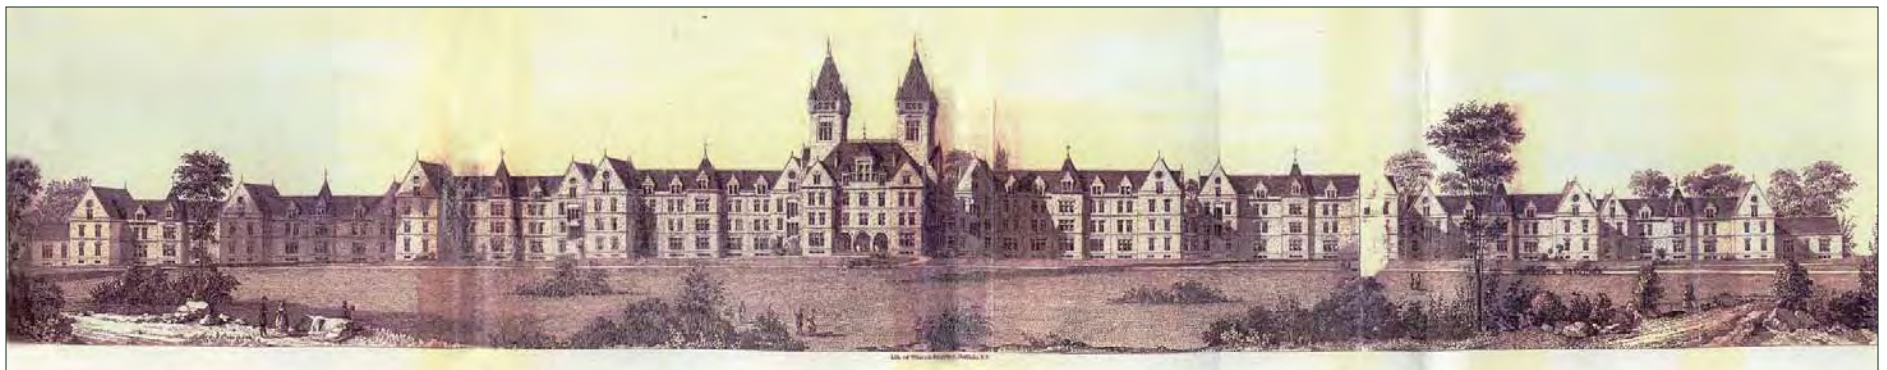
Figure III.15. **“Buffalo State Asylum for the Insane,” circa 1874.** Published in the early annual reports, the image shows an early view of the idealized asylum building and landscape, though it would take many years for both building and landscape to be completed. Image courtesy Buffalo and Erie County Public Library. (R-BRO-BSAI-AR-SouthFacade-Alt-1874.jpg)

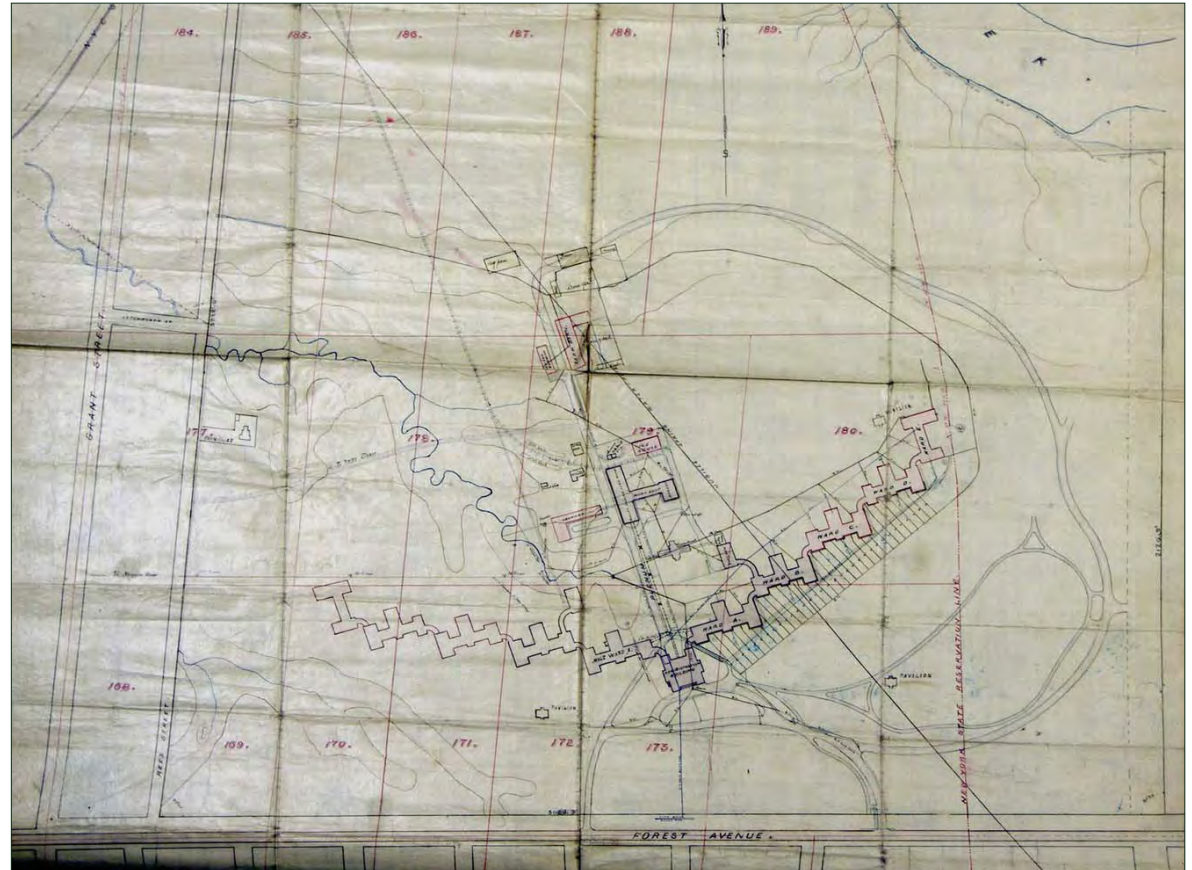
Figure III.16. “Plan of Grounds Belonging to the State Asylum for the Insane, Buffalo.” The plan depicts drives, walks, and the continued development of the service area. Image courtesy Buffalo Psychiatric Center. (R- BRO-BPC-1879to1891-SiteLayout-Bldgs-MW378-adj.jpg)

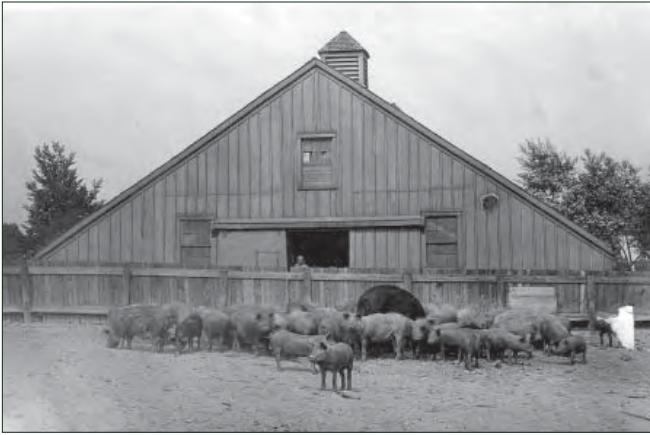
Figure III.17. View of the hog house and wood board fence that enclosed areas for livestock. Image Courtesy Buffalo Psychiatric Center. (R-BRO-GCA1-barn-pigs.jpg)

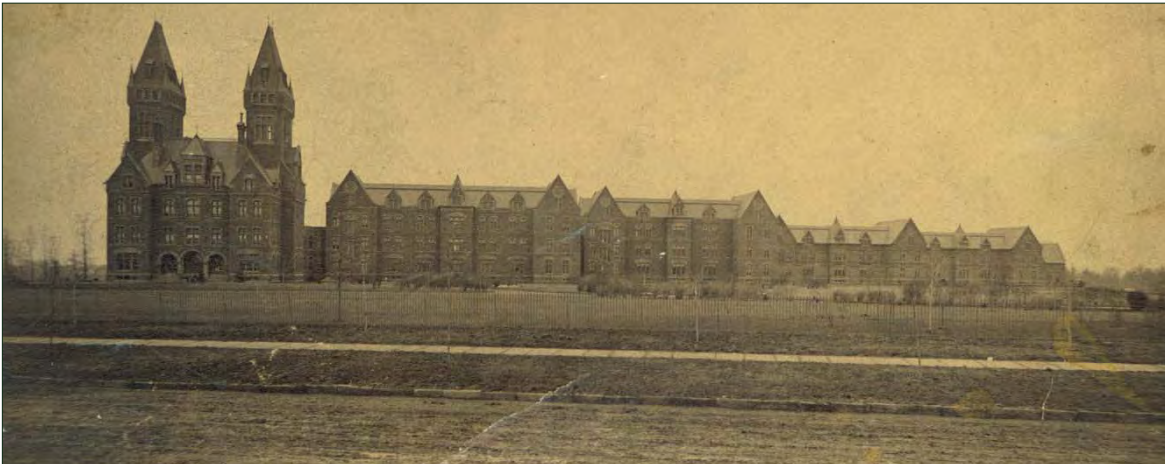
Figure III.19. Image of the grounds of the Buffalo State Asylum for the Insane, circa 1886. The image shows an iron picket fence, sidewalk and small trees lining Forest Avenue. Shrub masses are also seen on the asylum grounds. Also note the brownstone curb sections lining the unpaved street. Image courtesy Francis Kowsky. (R-BRO-FrancisKowsky-Admin-MensWard-1880.jpg)

not immediately available and the request was repeated for several years. In 1884, after a drop in the price of iron, an iron perimeter fence was constructed. The fence was constructed of wrought iron pickets with cast iron finials atop each picket. Over 3,000 feet of fencing were erected to line the property boundary along Forest Avenue. (See Figure III.19). Substantial bracketed iron footings were constructed and set in concrete underground. Medina brownstone piers were also constructed at this time to mark openings in the fence; two large and one small pier were constructed at the main entry drive along Forest Avenue.²⁸ (See Figure III.20). Funds were also requested for a six-foot wide Hudson River bluestone sidewalk along the entire Forest Avenue frontage; however, due to lack of funds the sidewalk was not constructed until 1886.²⁹

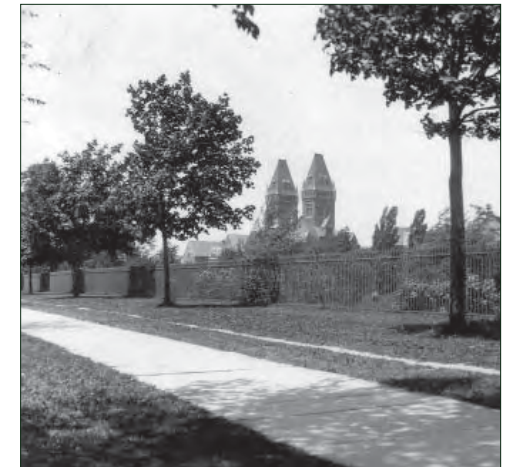
Figure III.22. **View looking into the asylum grounds from Forest Avenue.** A double row of street tree plantings and the iron perimeter fence define the property edge. Image Courtesy Buffalo Psychiatric Center. (R-BRO-GCA1-admin 10.jpg)

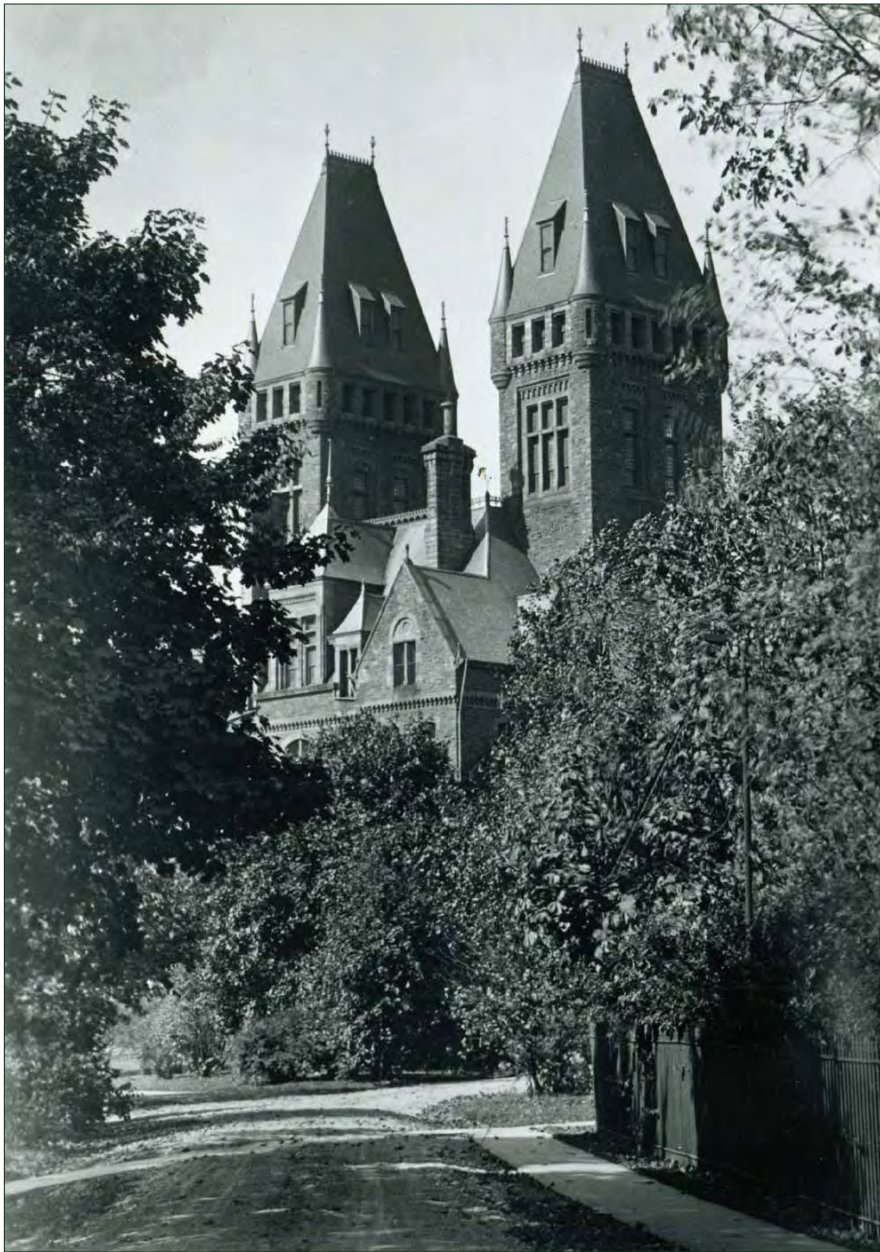
Figure III.27. **View looking northwest toward the central Administration Building and towers.** Iron fencing, visible at the right edge of the image, was erected, extending from the building to the primary site entrance on Forest Avenue. Image courtesy Francis Kowsky. (R-BRO-FrancisKowsky-FrontEntrance-nd.jpg)

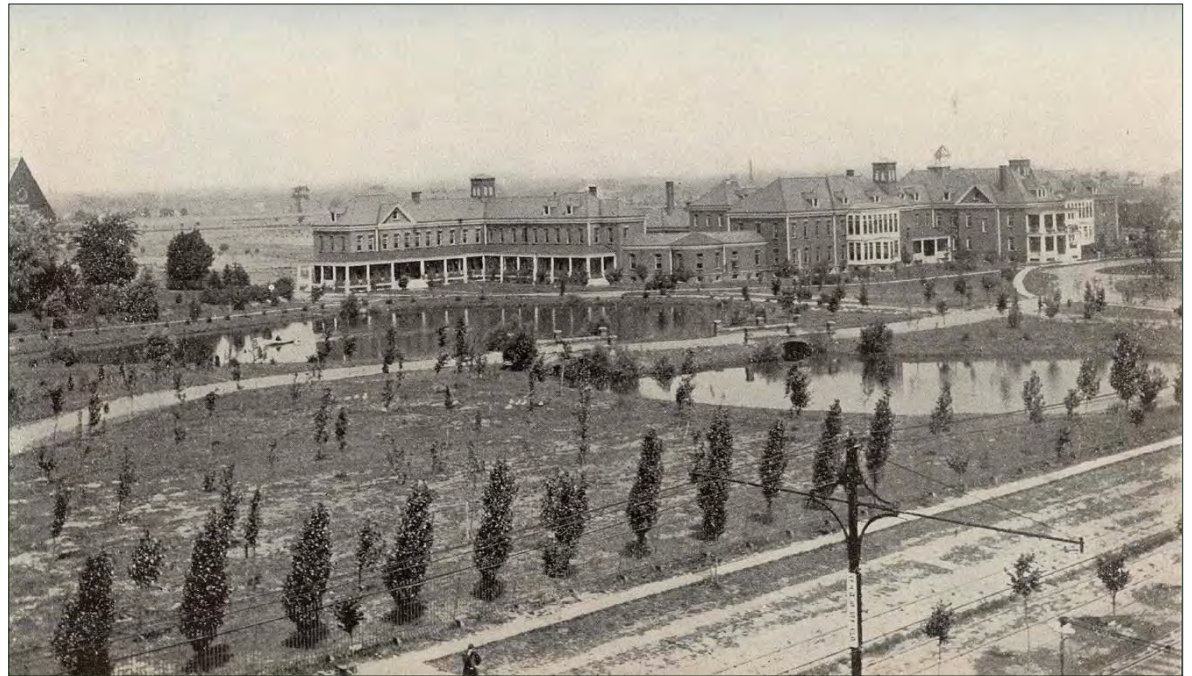
Figure III.28. **View looking toward the Elmwood Complex with Elmwood Avenue in the foreground.** Curving, tree-lined drive, ornamental pond, and stone bridge created a scenic buffer between the new facility, patient recreation area, and public street. Image courtesy Buffalo & Erie County Public Library. (R-BRO-BSAI-AR-ElmwoodAve-1900.jpg)

A secondary means of access was provided to the property with a tree allée-lined drive that branched off the main hospital entrance drive at Forest Avenue and curved through the scenic landscape. The drive crossed over a low-lying area that was converted into an ornamental pond, which narrowed in the center with a small island. The island was planted with elm trees and was crossed by a carriage bridge and separate footbridge. Trees and shrubs were planted around the pond, enhancing its park-like setting. Concrete walks were also constructed to provide access to the new hospital facilities.⁴⁷ (See Figures III.28 and III.29.)

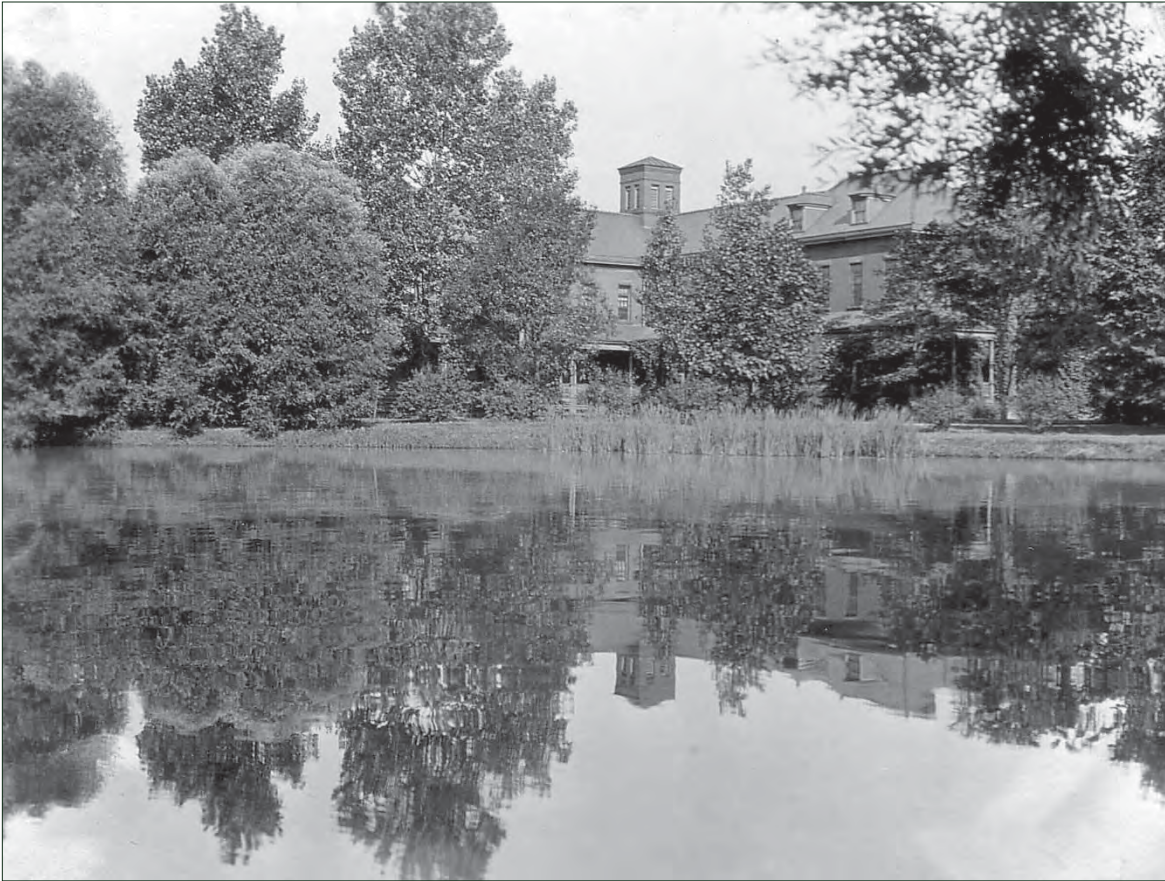
Figure III.29. **View looking across the constructed pond to the Elmwood Complex.** Dense tree and shrub plantings surrounding the pond and the new patient facilities added to the overall scenic character of the Buffalo State Hospital landscape. Image Courtesy Buffalo Psychiatric Center. (R-BRO-GCA1-bldg & pond.jpg)

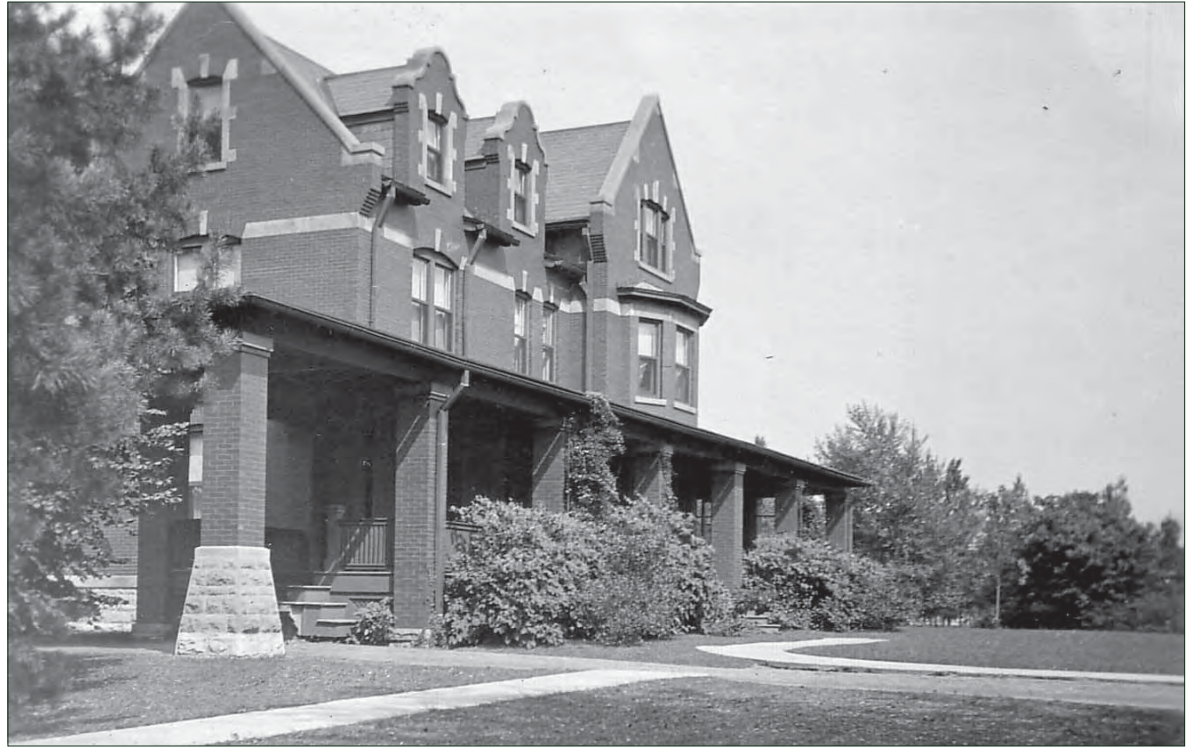
Figure III.33. **View of the south facade of the Superintendent’s Residence.** The macadam drive ran under the porte-cochere, visible at left. Image Courtesy Buffalo Psychiatric Center. (R-BRO-GCA1-SuperintendentRes.jpg)

New facilities for hospital staff were also constructed. These included a general staff residence and the superintendent’s residence, both of which were constructed in the southeast corner of the site, set on open turf, and screened from the public street frontage by dense vegetation. The superintendent’s residence also included a pool enclosed by a hedge and a tennis court. A macadam drive provided direct access from Forest Avenue.⁶⁰ (See Figures III.33 and III.34).
