CULTURAL LANDSCAPE REPORT

the **RICHARDSON OLMSTED COMPLEX** *Buffalo, NY*

October 2008

Heritage Landscapes
Preservation Landscape Architects & Planners

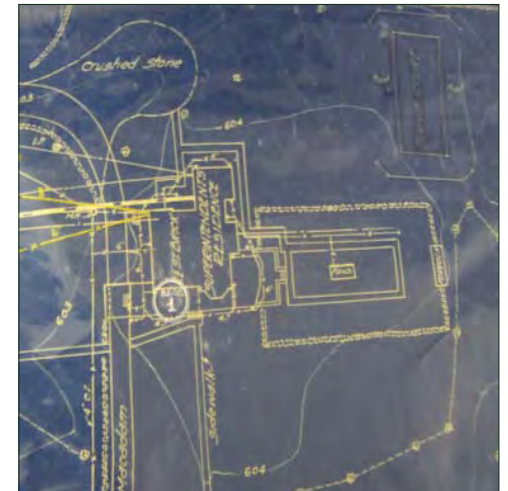
Figure III.34. **Detail of blueprint for construction of Superintendent’s Residence.** Pool and tennis courts are positioned to the east of the house. Image courtesy Buffalo Psychiatric Center. (R-BRO-BPC-Southeast-w-pool-tennis-c1905-MW402.jpg)

New facilities for hospital staff were also constructed. These included a general staff residence and the superintendent’s residence, both of which were constructed in the southeast corner of the site, set on open turf, and screened from the public street frontage by dense vegetation. The superintendent’s residence also included a pool enclosed by a hedge and a tennis court. A macadam drive provided direct access from Forest Avenue.⁶⁰ (See Figures III.33 and III.34).

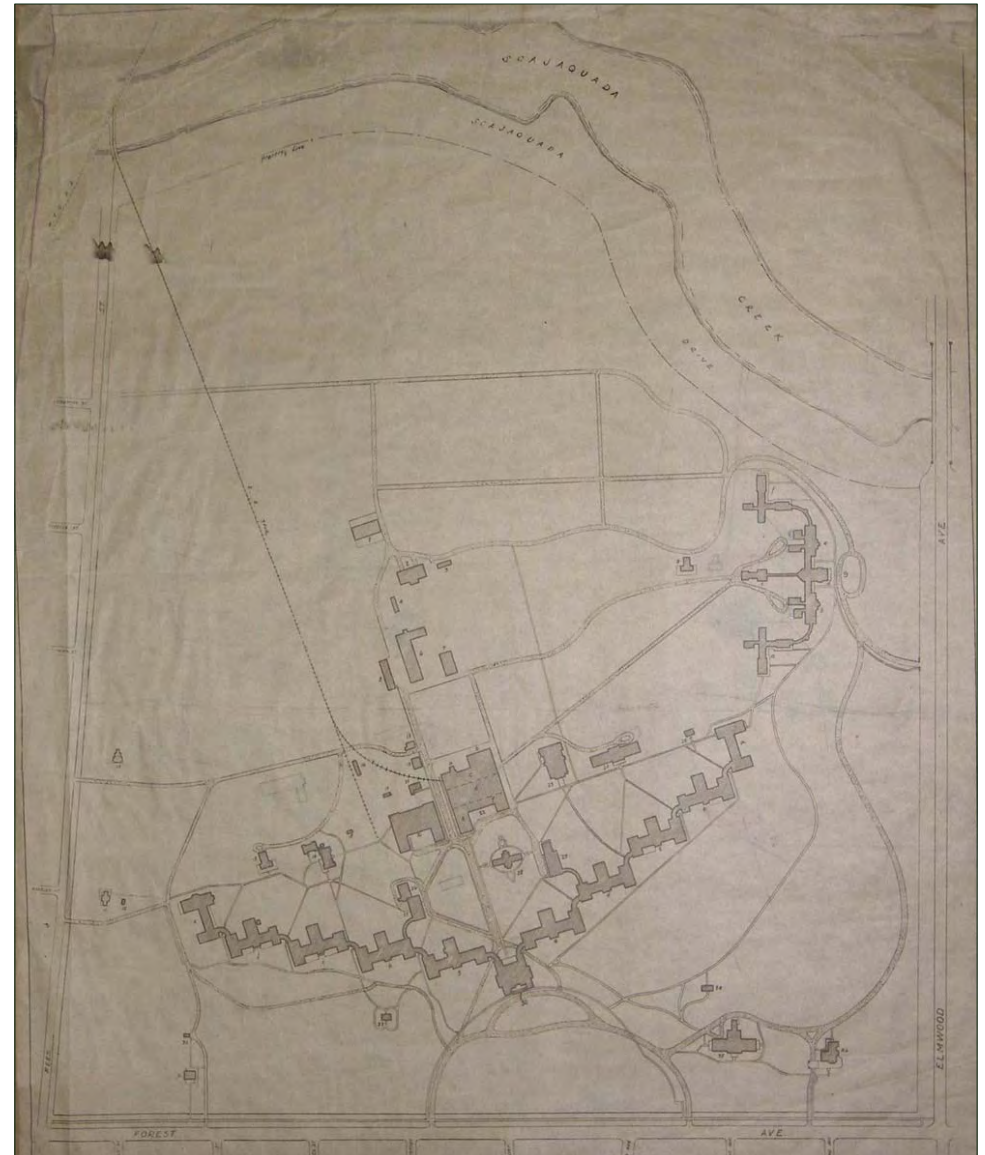
Figure III.37. “Buffalo State Hospital, Buffalo, N. Y., Map of the Grounds,” June 1912. The plan depicts the network of implemented drives and walks according to the Olmsted and Vaux design. Image courtesy Buffalo Psychiatric Center. (R-BRO-BPC-1912-Plan-of-Grounds-MW359-BCS.jpg)

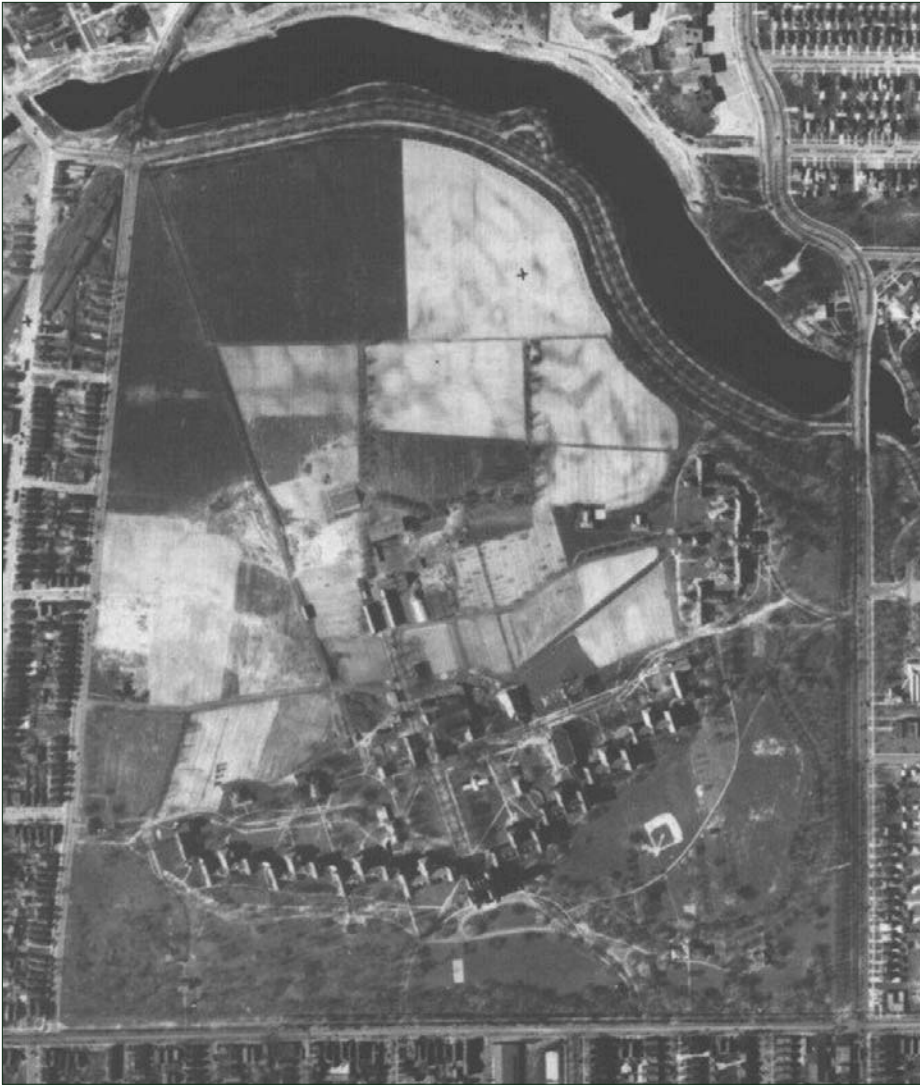
Figure III.39. **Aerial of the Buffalo State Hospital, 1927.** Image courtesy University of Buffalo Library. (R-BRO-UBL-Aerial-1927-crop.jpg)

At the start of the 1927-1949 period, the Buffalo State Hospital was a predominantly open campus landscape covering approximately 183 acres. Although the northern half had few structures, it was an important element in the broader landscape that greatly contributed to the overall scenic and pastoral character of the hospital grounds, provided necessary produce, and engaged patients in the therapeutic landscape. The graceful angle of the main Richardson complex to the south and the Elmwood Complex to the east framed the open farmlands and defined prominent frontages along the public streets. (See Figure III.39.)

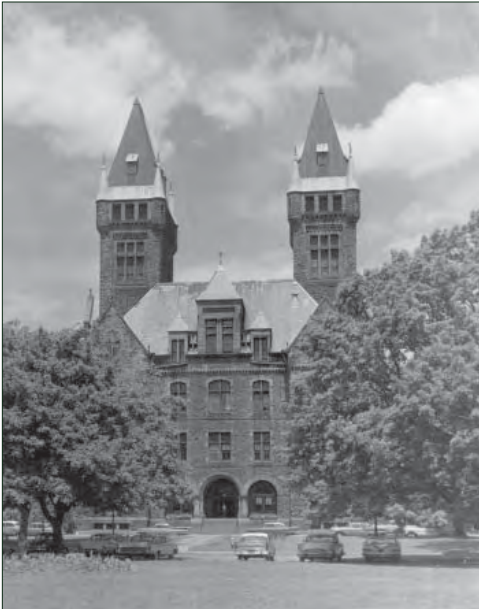
Figure III.41. **View looking north toward the central Administration Building.** In 1930, a parking lot was constructed south of the building, realigning the curved entry drive. Image Courtesy Buffalo Psychiatric Center. (R-BRO-GCA1-Admin, early 1960s18.jpg)

500 feet in length directly south of the Administration Building. The parking lot required the removal of lawn space and trees, changing the entry experience and views from Forest Avenue. (See Figure III.41.) The curved entry drive from Forest Avenue was also realigned and the iron fencing that extended from the Administration Building to the entry drive was removed. Other projects undertaken at this time included repainting 279 lawn benches, repairing drives, and removing and resetting 600 feet of iron fence at the rear of the hospital property.¹⁰⁸

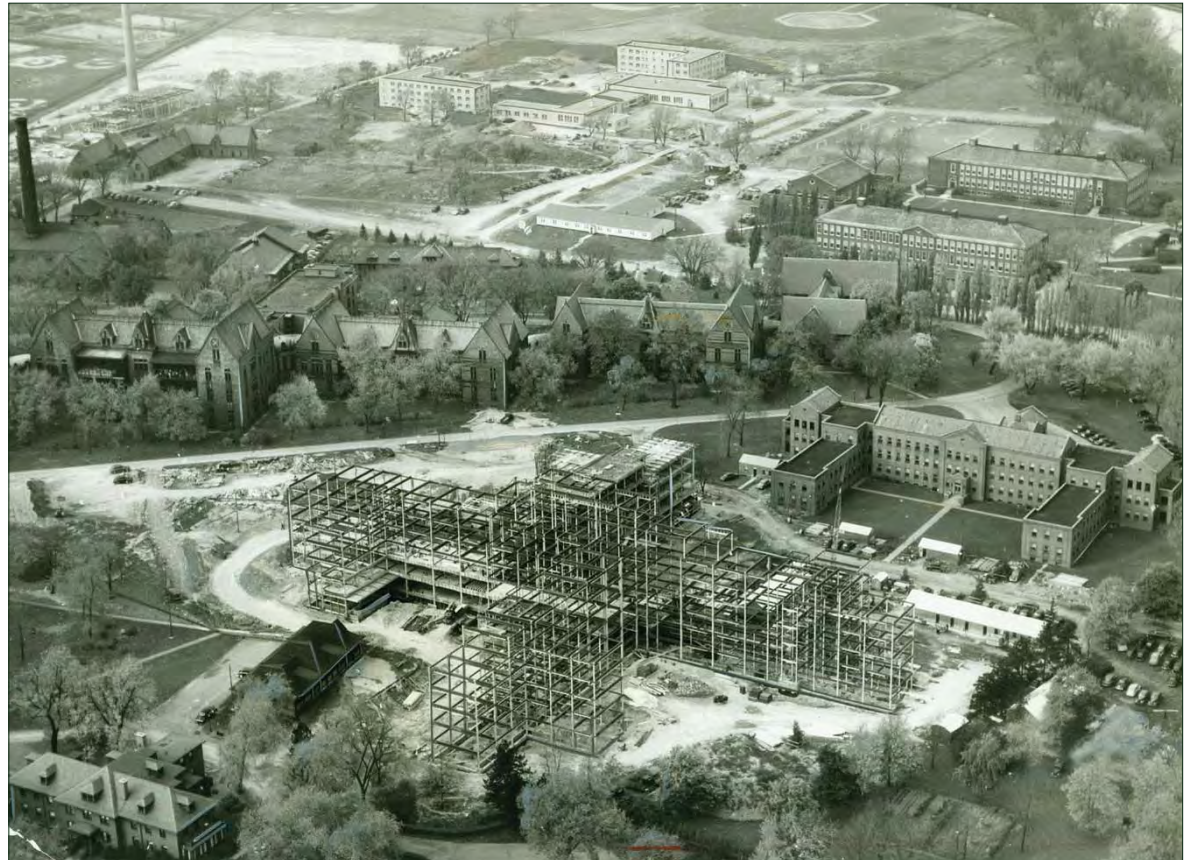
Figure III.44. **Oblique aerial of the medical-surgical building under construction, circa 1950.** The new patient facility was constructed over much of the open space available for patient recreation. Image courtesy Buffalo & Erie County Historical Society. (R-BRO-BHS-6a.jpg)

In 1950, improvements and new construction at the Buffalo State Hospital began with the construction of a medical-surgical building that was considerably larger in scale than other hospital buildings. (See Figure III.44.) The new five-story building was constructed in the open turf near the southeast corner of the site. Prior to construction, this area conveyed a strong park-like character with tree and shrub massings and a curving access drive. The placement of the new building required the removal of the patients' baseball field, decreasing opportunities for recreational activities. It also necessitated the second realignment of the original drive designed by Olmsted and Vaux that once curved from the main entrance drive at Forest Avenue north and east to the rear support cluster and later to the Elmwood Complex. A staff residence was also removed. Access drives and parking lots were constructed following the completion of the new building.¹³⁶ (See Figure III.45.)

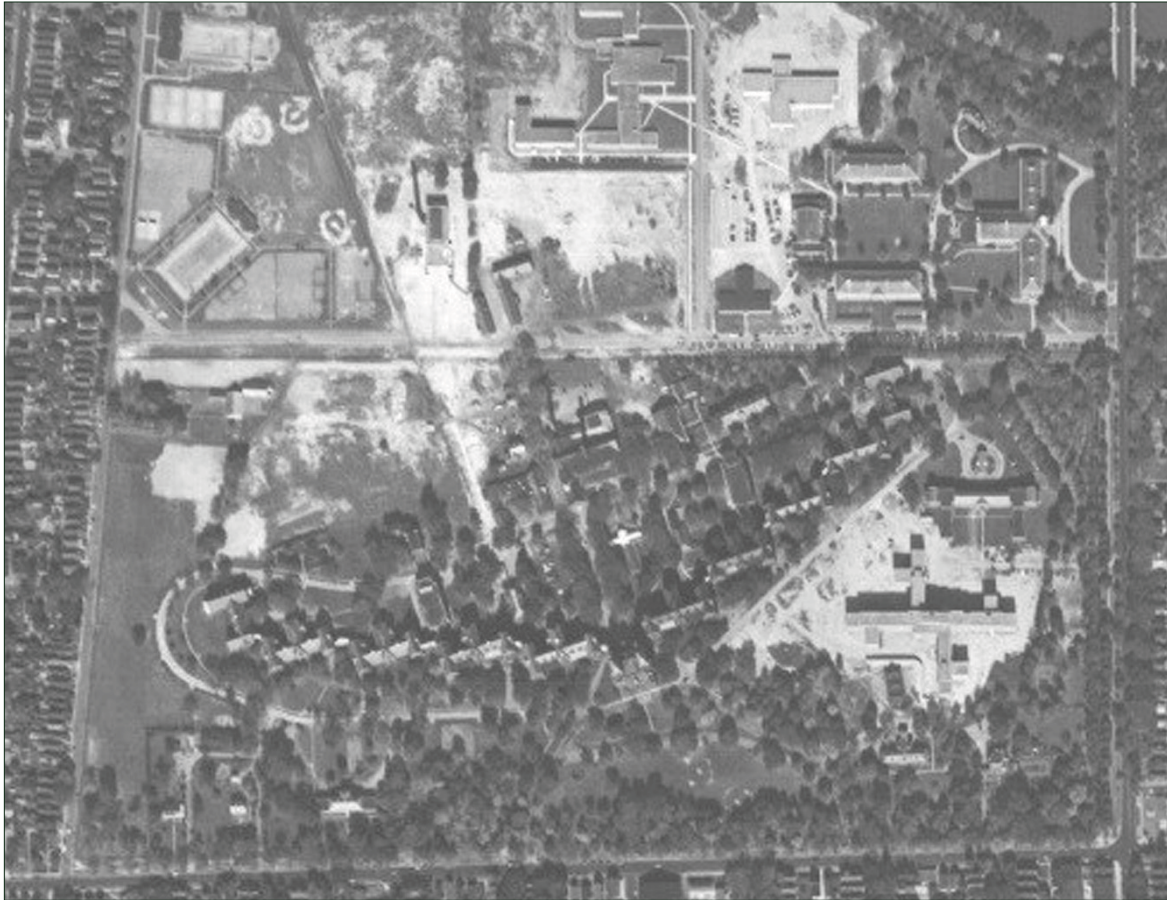
Figure III.45. Aerial of the Buffalo State Hospital, 1951. Substantial landscape alterations were required with the medical-surgical building. Image courtesy Erie County Public Works. (R-BRO-EPW-Aerial-1951-crop.jpg)

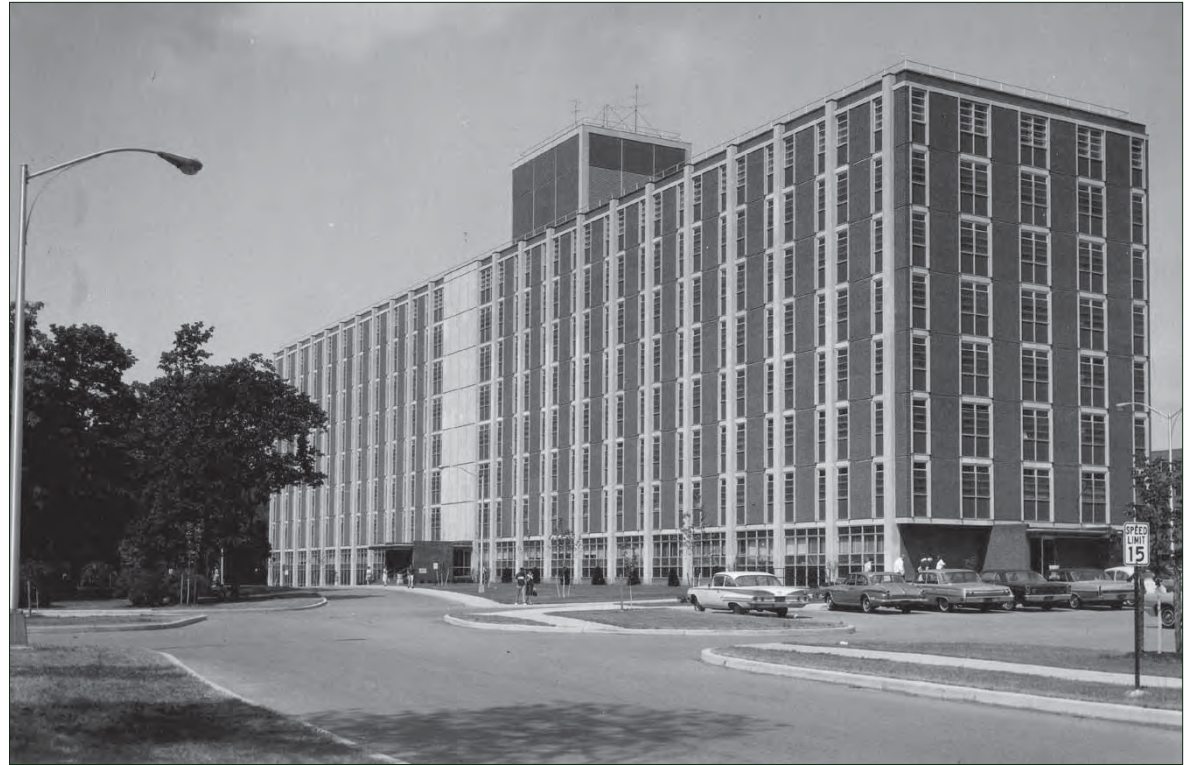
Figure III.48. **View of the Strozzi Building.** The patient facilities constructed during this period decreased the open space available for patient recreation. Image Courtesy Buffalo Psychiatric Center. (R-BRO-GCA1-Strozzi c196421.jpg)

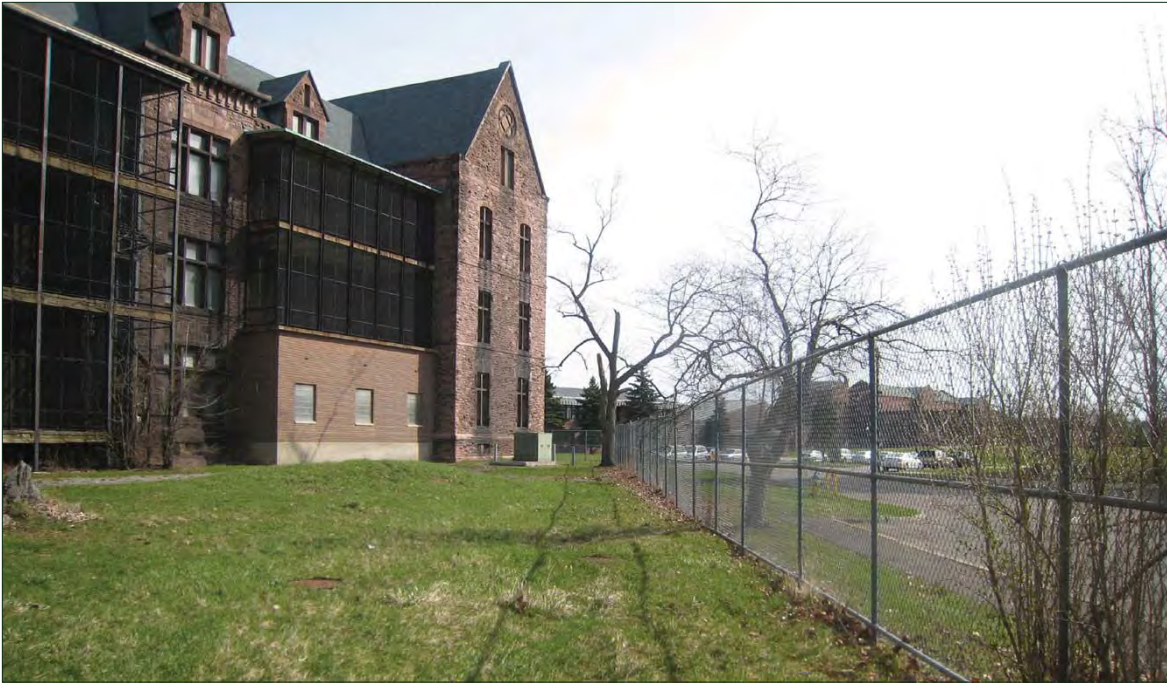
Figure III.49. **View of contemporary brick addition on one of the male ward buildings to house offices for the Buffalo Psychiatric Center.** Following the relocation of the offices, a chain-link fence was installed around the Richardson building complex. Image courtesy HL (R-BRO-2008-04-16_0173.jpg)

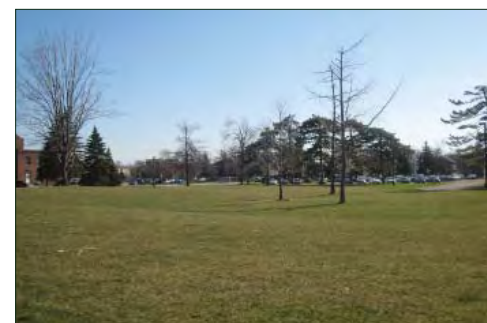
Figure III.50. **View of area once occupied by the medical-surgical building.** Removal of the building regained open space in the hospital landscape. Image courtesy HL. (R-BRO-2008-04-17_0096.jpg)

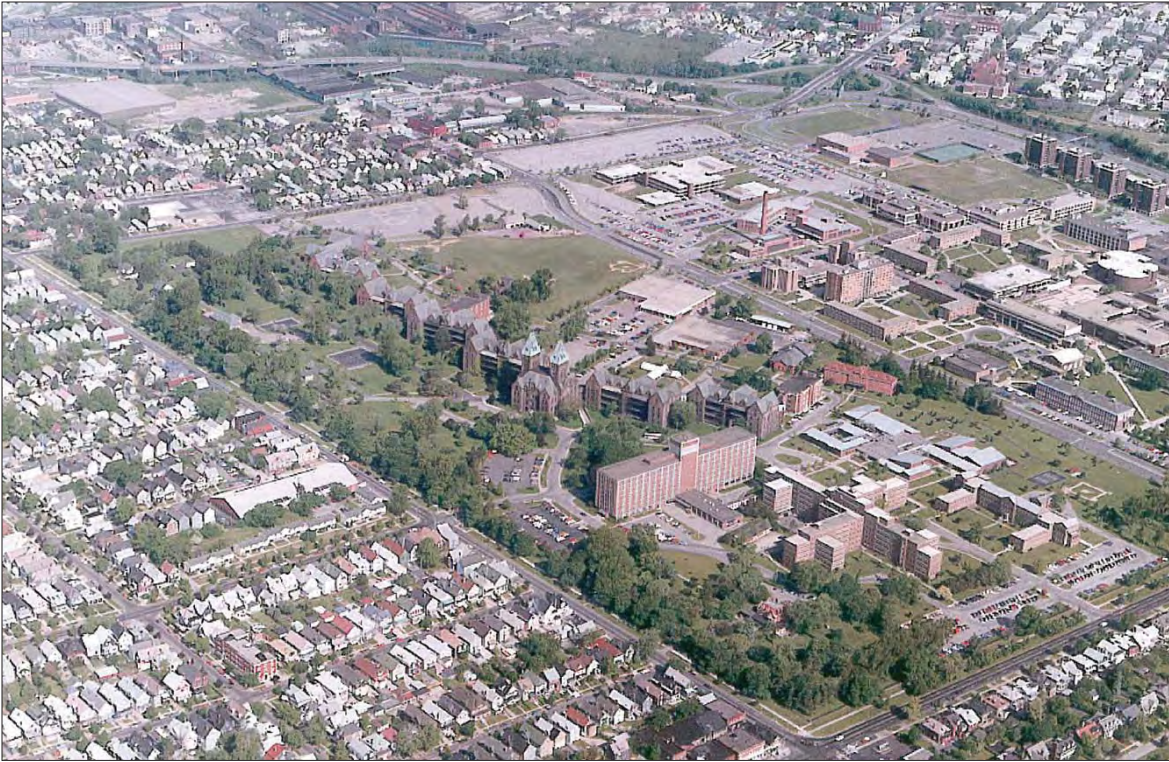
Figure III.55. **Circa mid-1990s oblique aerial of the Richardson Olmsted Complex.** The original building complex is sited near the center of the remaining hospital grounds and the eastern portion of the landscape has been substantially developed since the end of the historic period in 1927. New patient facilities have decreased the open, recreation space, which was integral to the character and function of the therapeutic landscape. The entire northern area, which was historically open farmlands, has been extensively developed for the Buffalo State College. Note the reception building visible in this image has since been demolished. Image reproduced courtesy Urban Land Institute Briefing Book. (R-BRO-ULIReport-2007-pg25.jpg)

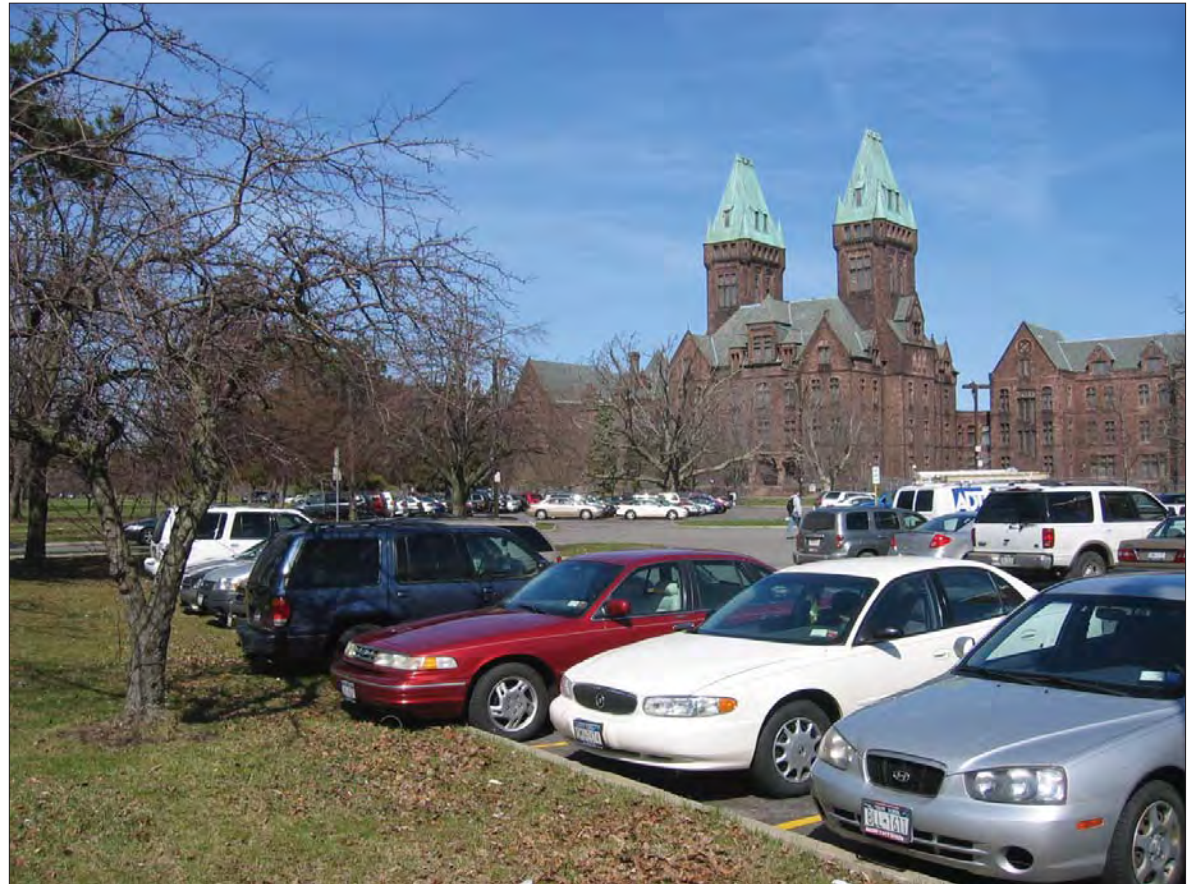
Figure IV.1. **View looking toward the south façade of the visually dominant main complex of asylum buildings.** The entrance landscape is defined largely by asphalt parking lots and open lawn interspersed with trees. Image courtesy of HL. (R-BRO_20080416_1357.jpg)

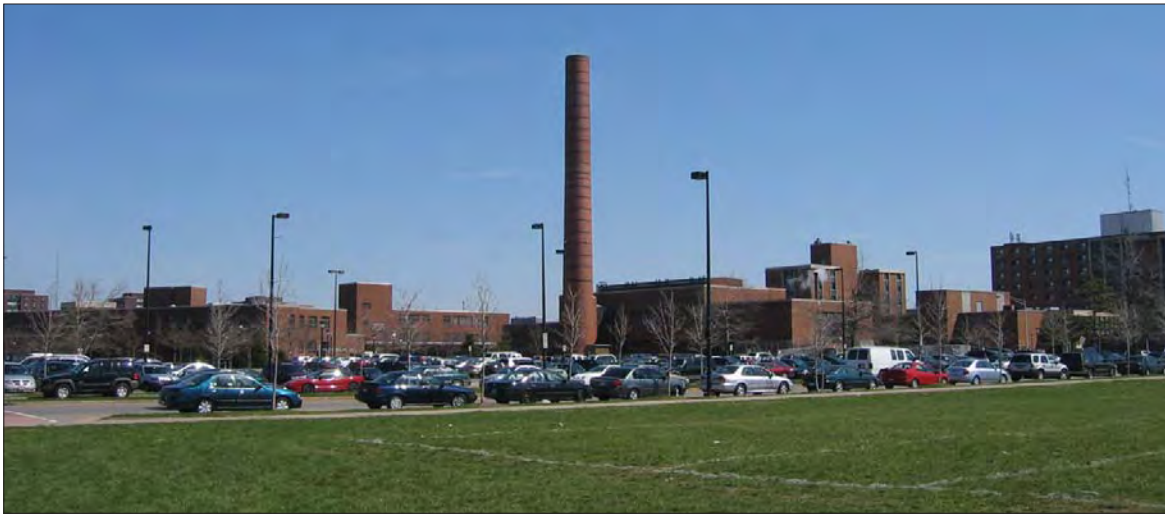
Figure IV.2. **View looking north toward the service area and former farmlands.** Much of this area was once open with minimal landscape features, but has been developed as part of Buffalo State College. Courtesy HL. (R-BRO_20080417_1434.jpg)

main site entrance, remain relatively open. The agricultural fields no longer exist. Former open fields north of Rockwell Road have been transformed into the campus of Buffalo State College. (See Figure IV.2). Expansive surface parking has become a prominent landscape feature throughout the site.

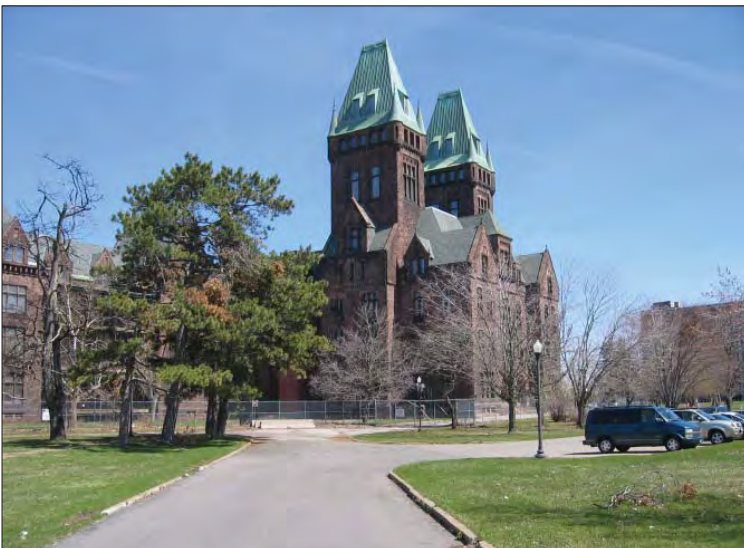
Figure IV.3. **View looking toward the main building complex with remnant curvilinear drives.** Much of this area has changed with alterations in circulation routes and loss of vegetation. Courtesy HL. (R-BRO_20080416_1363.jpg)

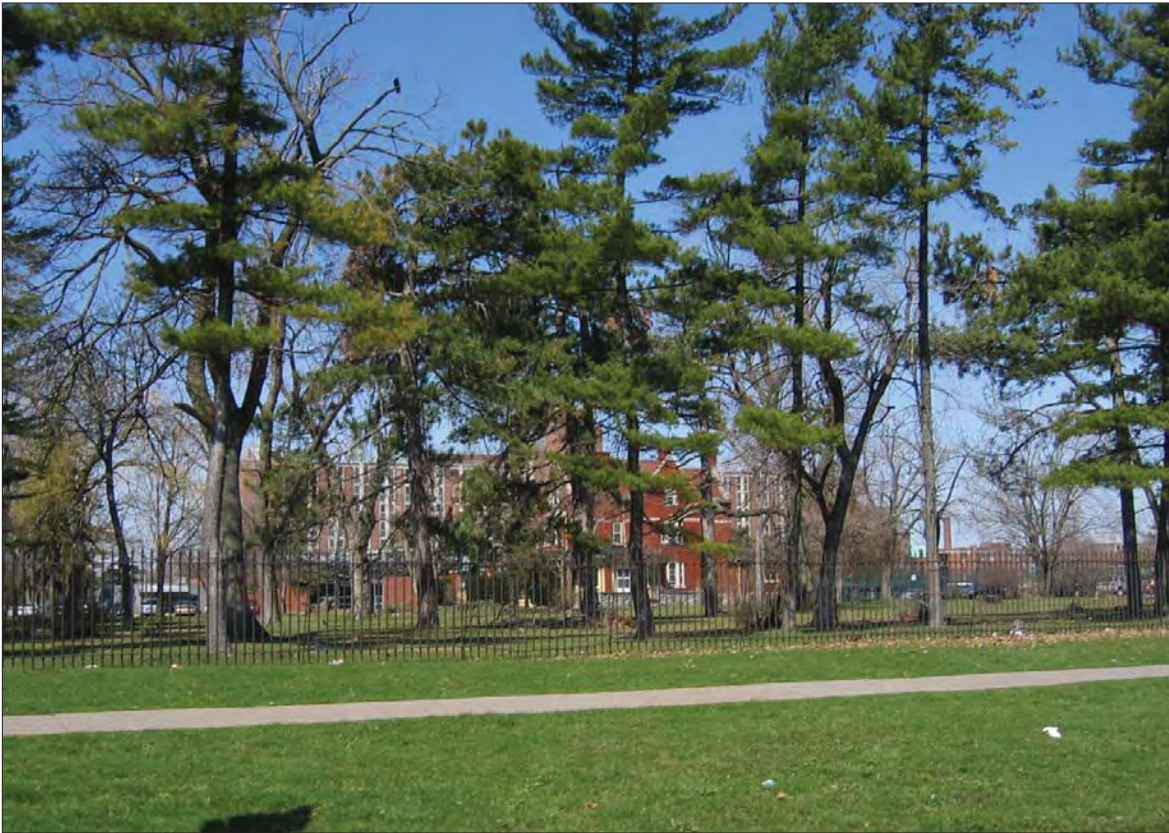
Figure IV.4. **View of the southeast corner of the Richardson Olmsted Complex.** A group of mature trees remain in this area, revealing the former park-like landscape character. Courtesy HL. (R- BRO_20080417_1445.jpg)

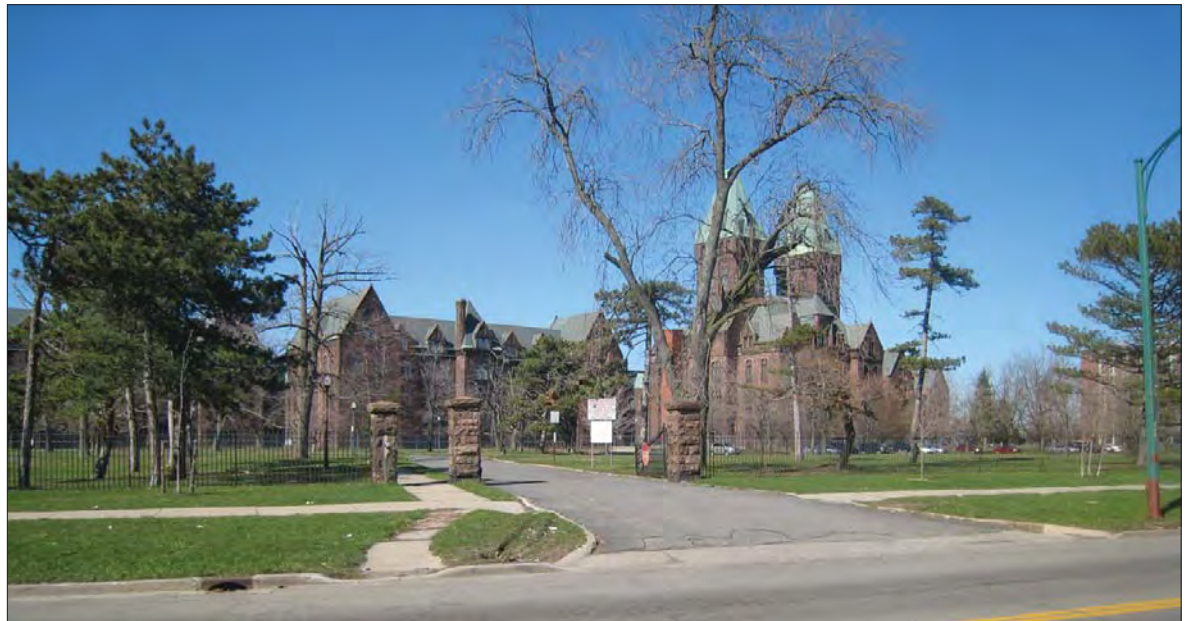
Figure IV.5. **View from Forest Avenue looking toward the historic entry drive, iron fence, and brownstone piers of the Richardson Olmsted Complex landscape.** Courtesy HL. (R- BRO-2008-04-16_0134.jpg)

original entry drive defines the southwestern edge of the area with a new parking lot at the southeast edge. Historic iron fencing lines the Forest Avenue frontage of the landscape and three brownstone piers mark the entry drive and adjacent pedestrian walkway. (See Figure IV.5.) The curvilinear drive that wraps around the west and north edges of the main building complex provides visual definition between this landscape unit and adjacent areas. A cluster of buildings, walks, and drives that have been added and realigned since the end of the historic period define the east portion of the landscape unit, beyond the main building complex.

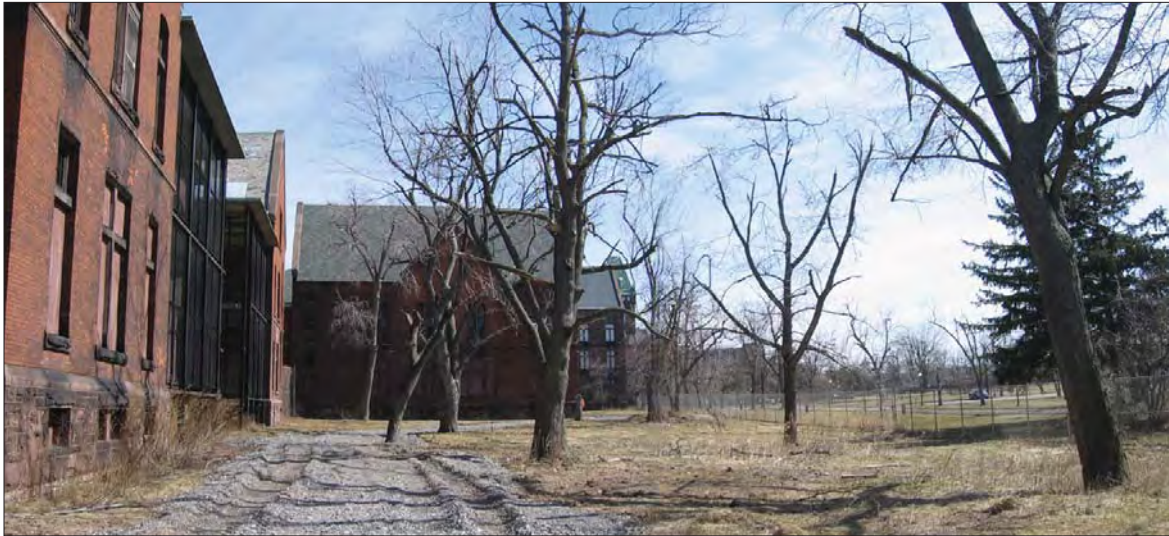
Figure IV.6. **The spatial relationship between the main building complex, open turf, and trees contribute to the character of Unit 2.** The temporary gravel drive has created additional stress for declining trees. Courtesy HL. (R- BRO-Panorama4-04-03-08.jpg)

The relationship between the original building complex, the surrounding mown turf ground plane, tree plantings, gracefully curving drives and cluster of additional buildings characterize this unit. (See Figures IV.6, IV.7 and IV.8.) Spatially this area is defined by the sprawling historic building complex that extends on a diagonal axis across the center of the landscape. The building complex remains the visually dominant feature not only in this unit, but in the overall landscape. The soaring twin towers draw views toward the central landscape, highlighting the former character of the landscape. (See Figure IV.9.)

combination of natural decline, construction of new parking lots and drives, and damage sustained during winter storms. A temporary gravel drive has been laid out around much of the main building complex as part of building stabilization efforts. This has created additional stress to the trees, many of which are already in decline. (See Figures IV.6 and IV.10.) The street trees planted along the frontage of Forest Avenue also exhibit signs of decline with several missing from the once continuous, double staggered row. A number of young trees have recently been planted in an effort to recapture the former landscape character along the street front.

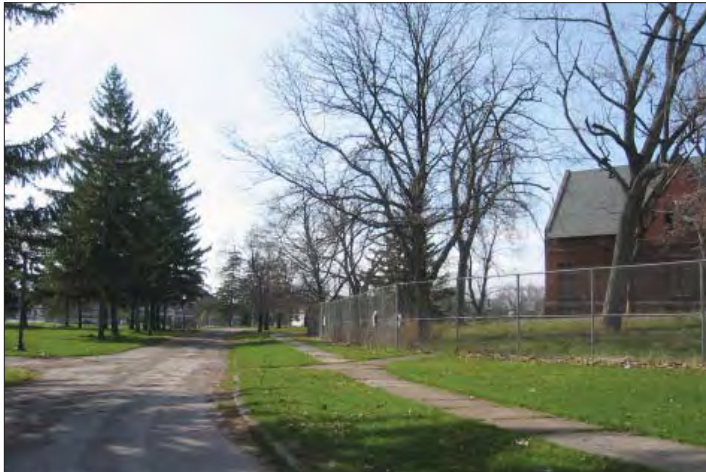
Figure IV.7. **Graceful drives curve around the main building complex.** Today, some drive segments are remnants of historic drives and contribute to the landscape character. Courtesy HL. (R- BRO_20080417_1572.jpg)

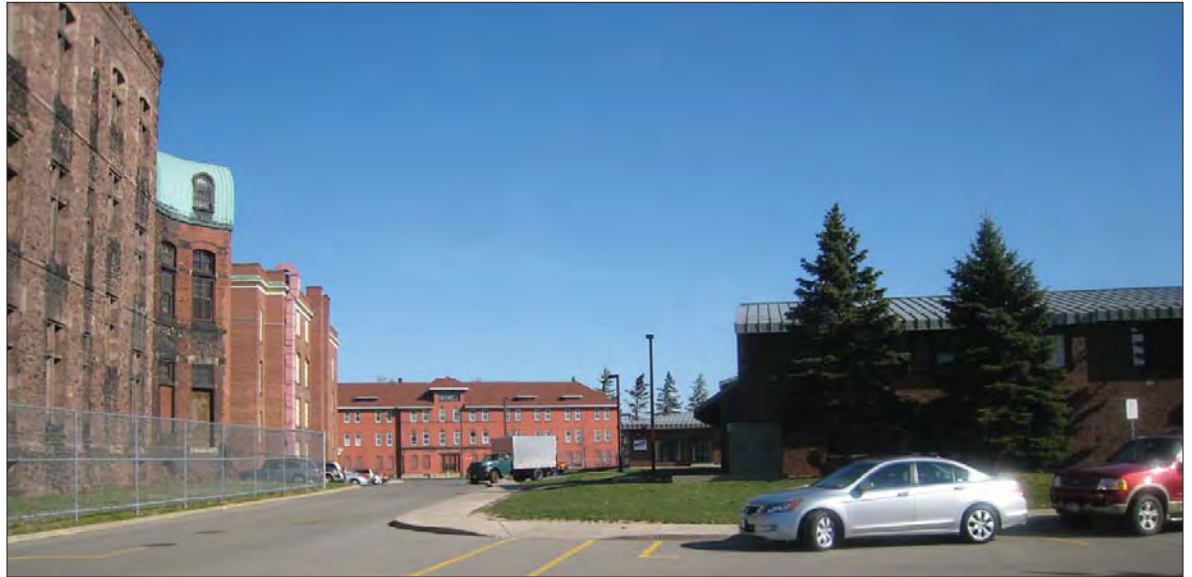
Figure IV.8. **A cluster of newer buildings and reconfigured drives and walks located at the east end of the main building.** These affect the overall existing character of the landscape. Courtesy HL. (R- BRO-2008-04-17-0018.jpg)

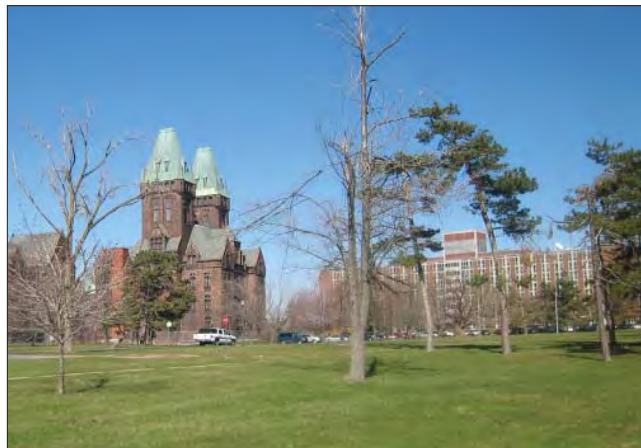
Figure IV.9. **View of the towers of the Administration Building.** The towers remain visually dominant in the currently fragmented historic landscape. Courtesy HL. (R- BRO-2008-04-16_0122.jpg)

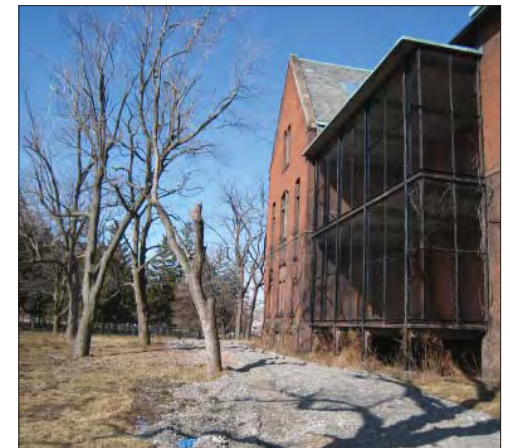
Figure IV.10. **Many existing trees exhibit damage,** likely as result of both compaction from the gravel construction drive and winter storm events. Courtesy HL. (R- BRO_20080403_0973.jpg)

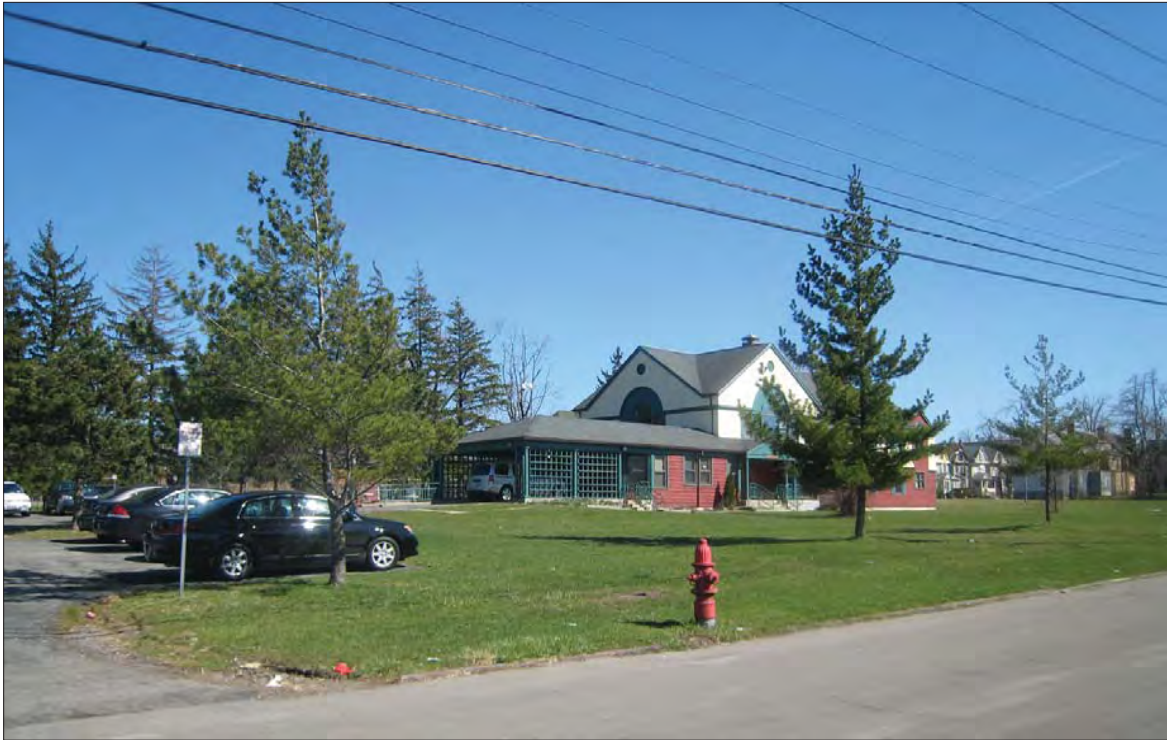
Figure IV.11. This view along Rees Street illustrates **the open relationship in the southwest corner of the site created by the few buildings and structures, open turf, and scattered trees, defining the general spatial character of Landscape Unit 3.** Courtesy HL. (R- BRO-2008-04-16_0060.jpg)

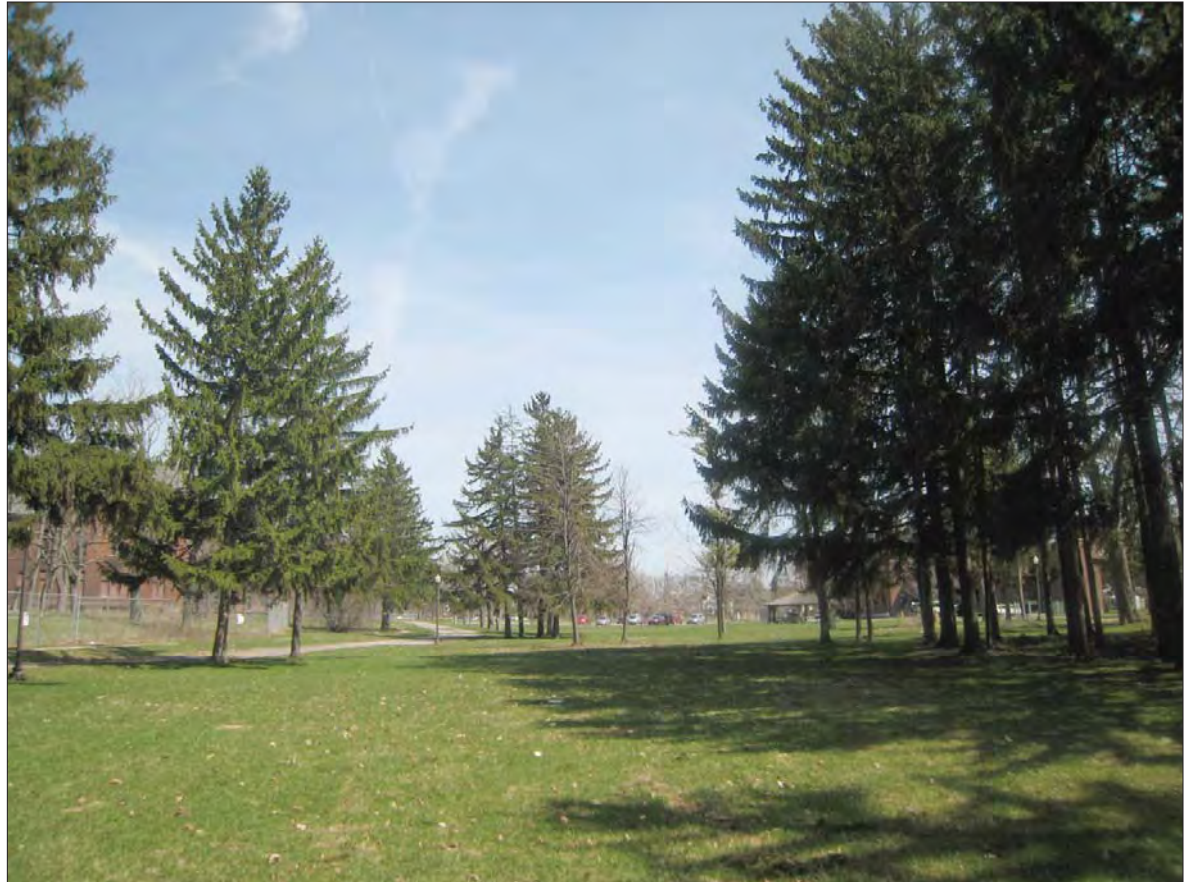
Figure IV.12. **The relationship between the curving drive, generally open ground plane, and sheltered grove creates a scenic, park-like character in Landscape Unit 3.** The partially shaded curving drive is visible at left and the evergreen grove is visible at right. Courtesy HL. (R- BRO-2008-04-17-0319.jpg)

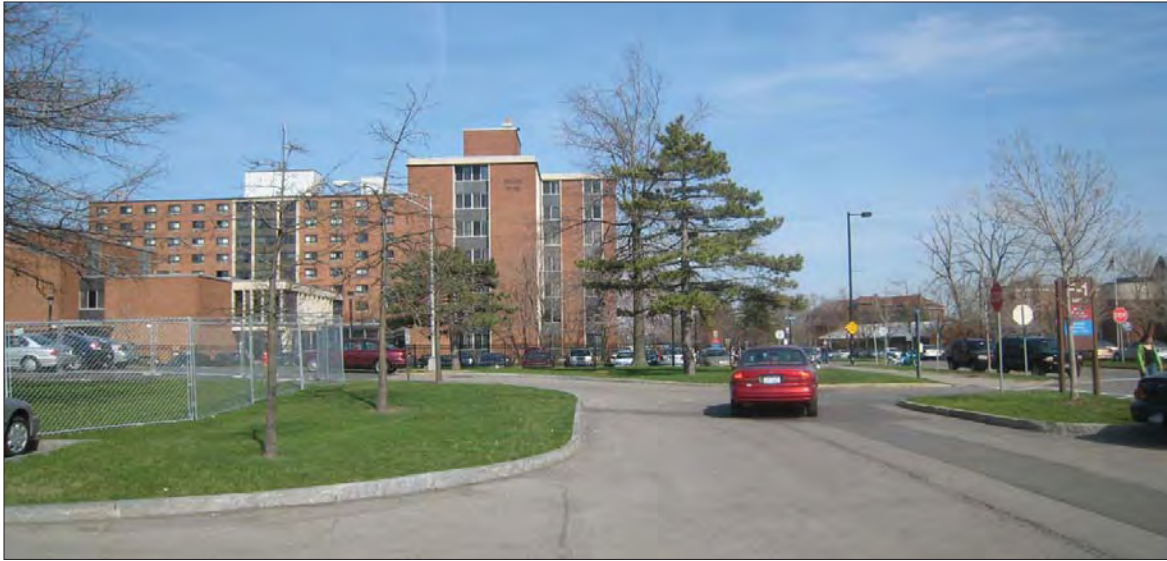
Figure IV.13. **The northern area of Landscape Unit 4 once functioned as part of the asylum service area.** Today the landscape character and features have little cohesion with the broader asylum landscape. Courtesy HL. (R- BRO-2008-04-17-0419.jpg)

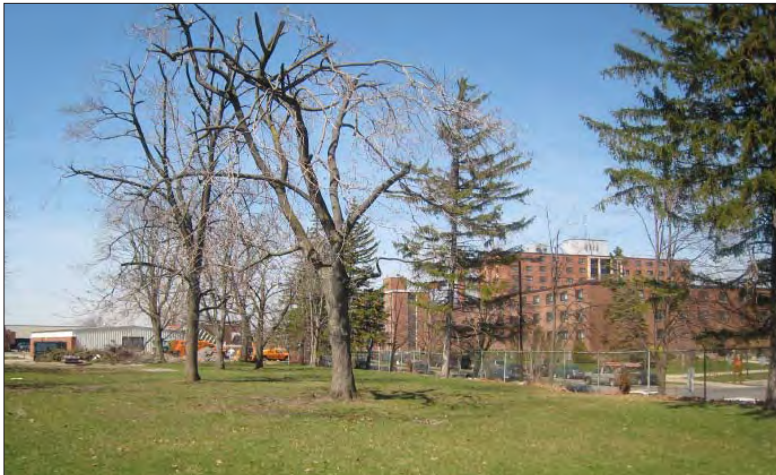
Figure IV.14. **Much of Landscape Unit 4 currently functions as a maintenance area.** The open lawn and scattered trees in this section convey a landscape character that is somewhat park-like and relates to the broader asylum landscape character. Courtesy HL. (R- BRO-2008-04-17-0190.jpg)

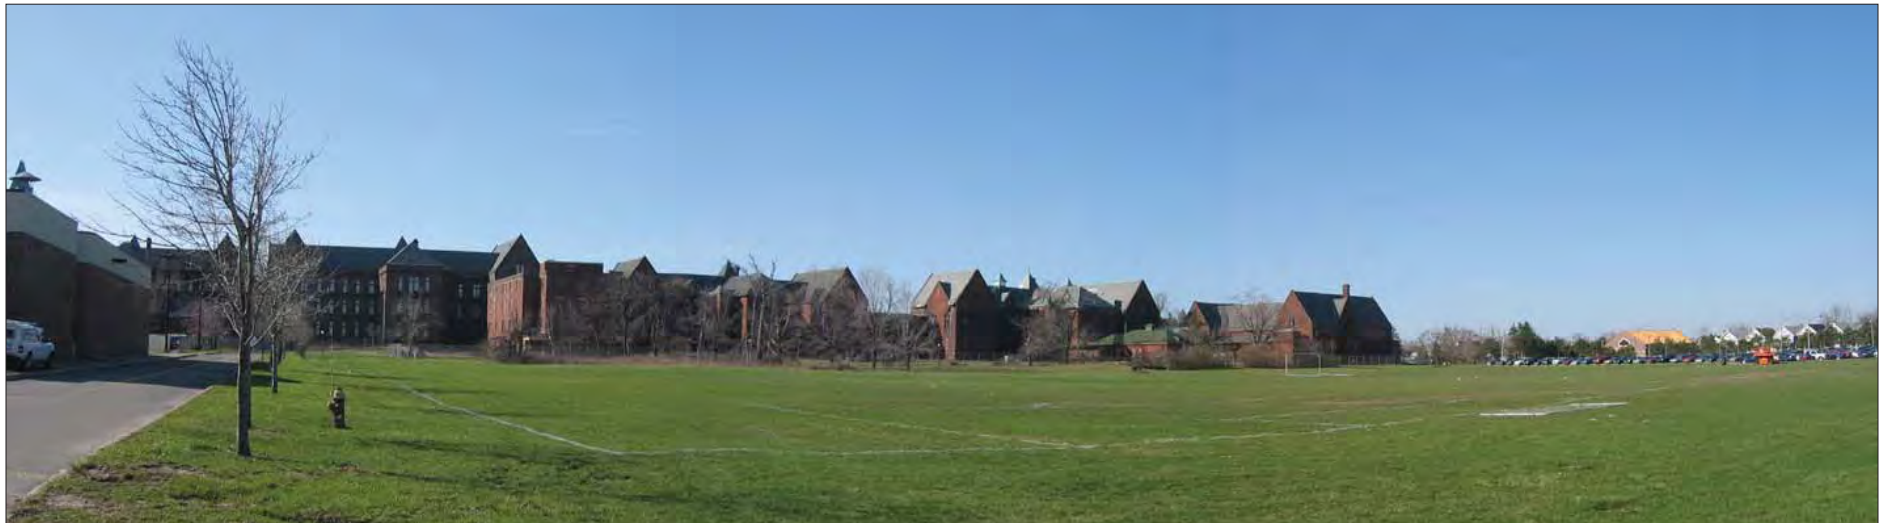
Figure IV.15. **The open character of the turf field in Landscape Unit 5 contributes to the overall character of this unit and conveys the historically open character of the former farmlands.** Courtesy HL. (R- BRO-20080417-Panoramic1.jpg)

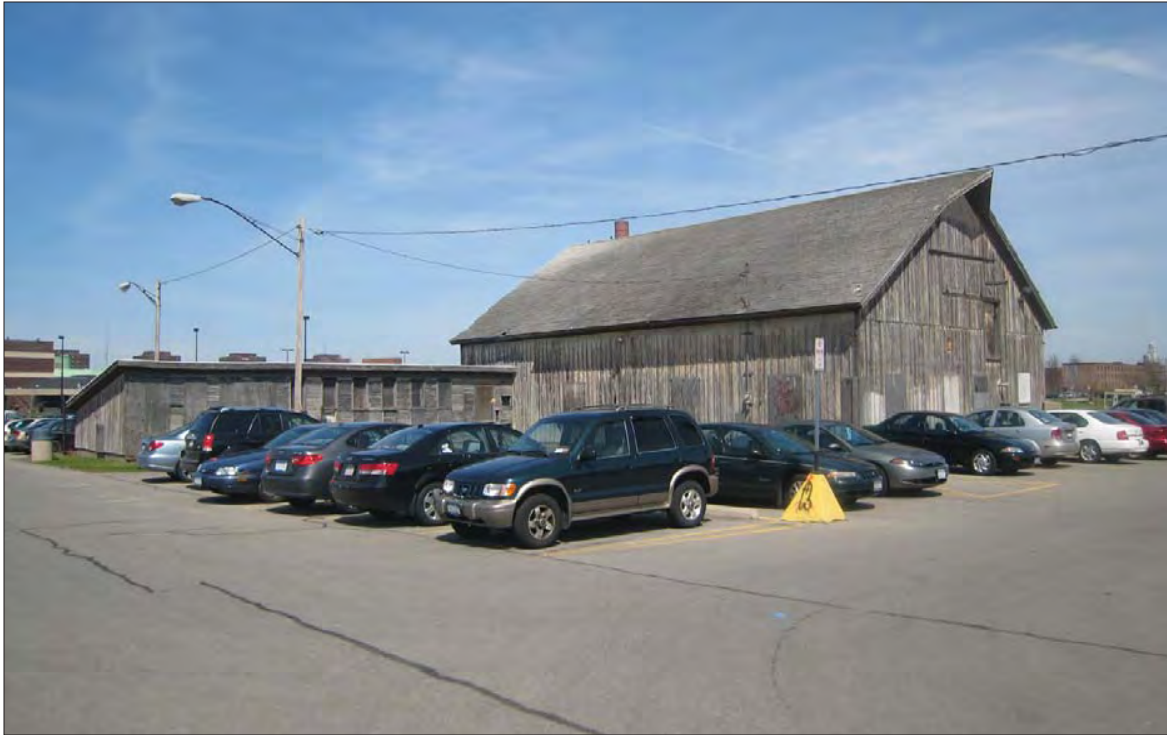
Figure IV.16. **View of asphalt parking lot constructed surrounding the former asylum historic wagon shed.** Courtesy HL. (R- BRO-2008-04-17-0327.jpg)

a parking lot, and a circa 1928 asylum wagon shed located along Rees Street, south of Rockwell Road. The majority of the farmland became part of the Buffalo State College campus in 1927. Since then this northern area has been incrementally developed by the college, and today it presents a campus-like landscape character.
