CULTURAL LANDSCAPE REPORT

the **RICHARDSON OLMSTED COMPLEX** *Buffalo, NY*

October 2008

Heritage Landscapes
Preservation Landscape Architects & Planners

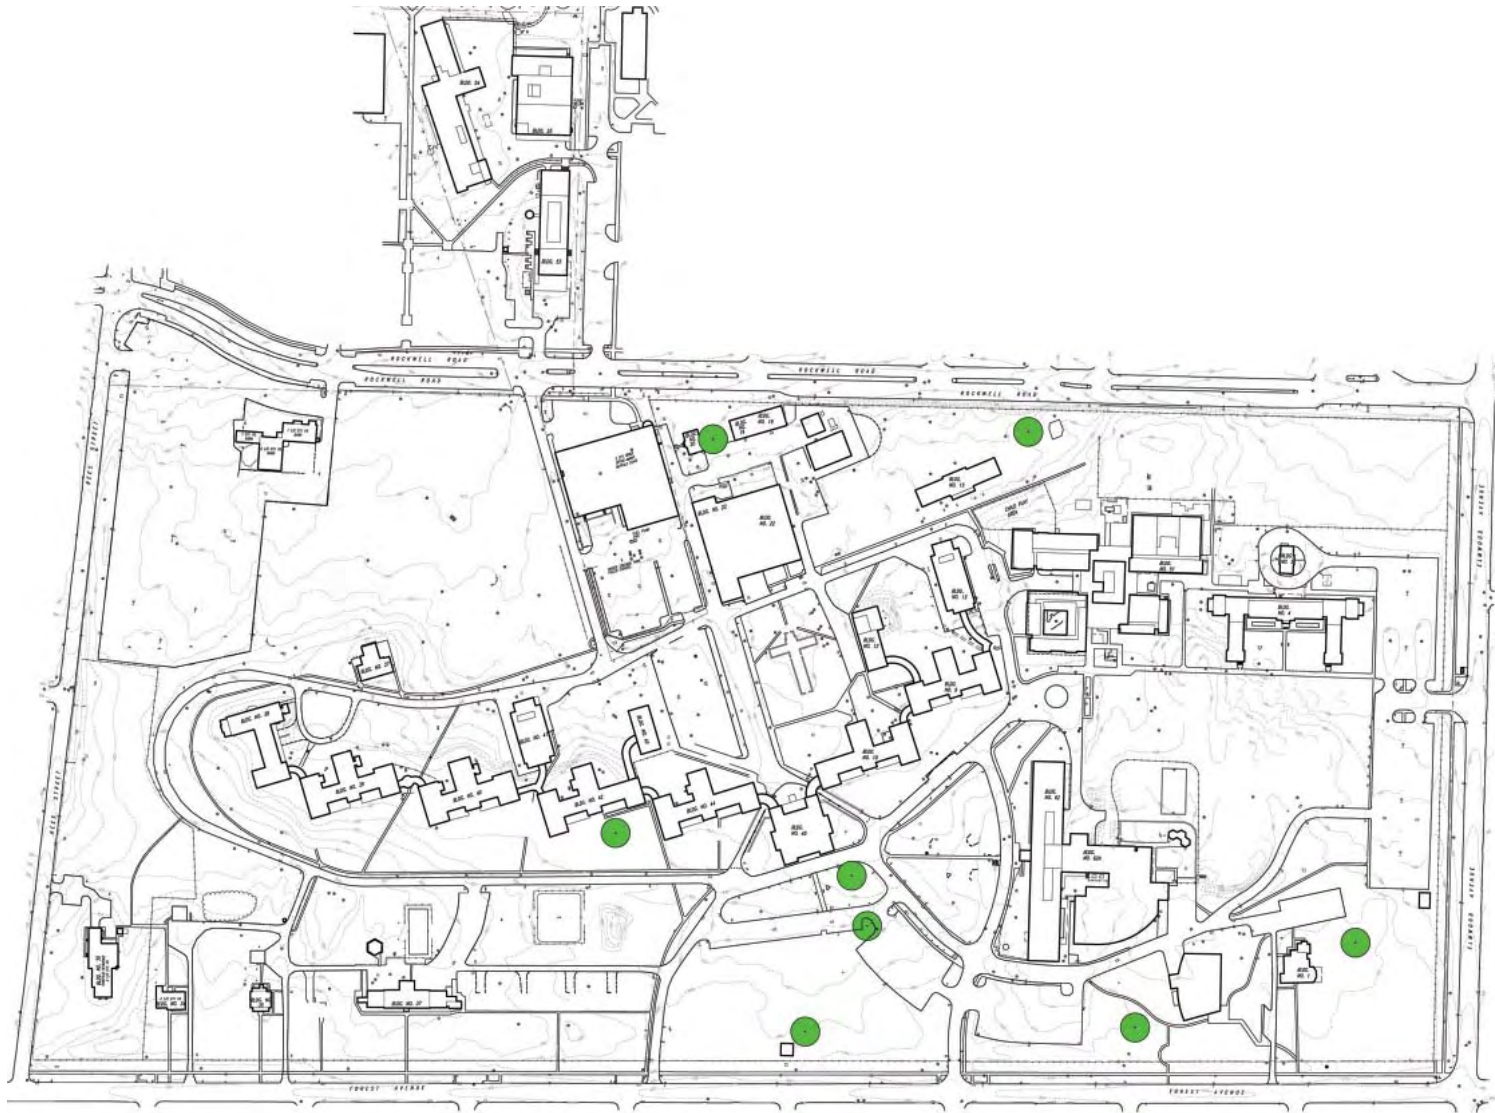
Trees Over 45" Caliper

The five largest documented trees in the landscape range from 50 to 65 inches in caliper, or diameter. The largest is an ash with a 65-inch caliper; second is a 57-inch ash, third is a 55-inch Norway maple, fourth is a 52-inch cottonwood (*Populus deltoides*); and fifth is a 50-inch swamp white oak (*Quercus bicolor*). These trees along with two others of a slightly smaller diameter are the largest trees remaining in the landscape today. These trees were likely present at the time that the site was selected for the Buffalo State Insane Asylum in 1871. The largest trees are highlighted on the plan *Trees Over 45" Caliper*.

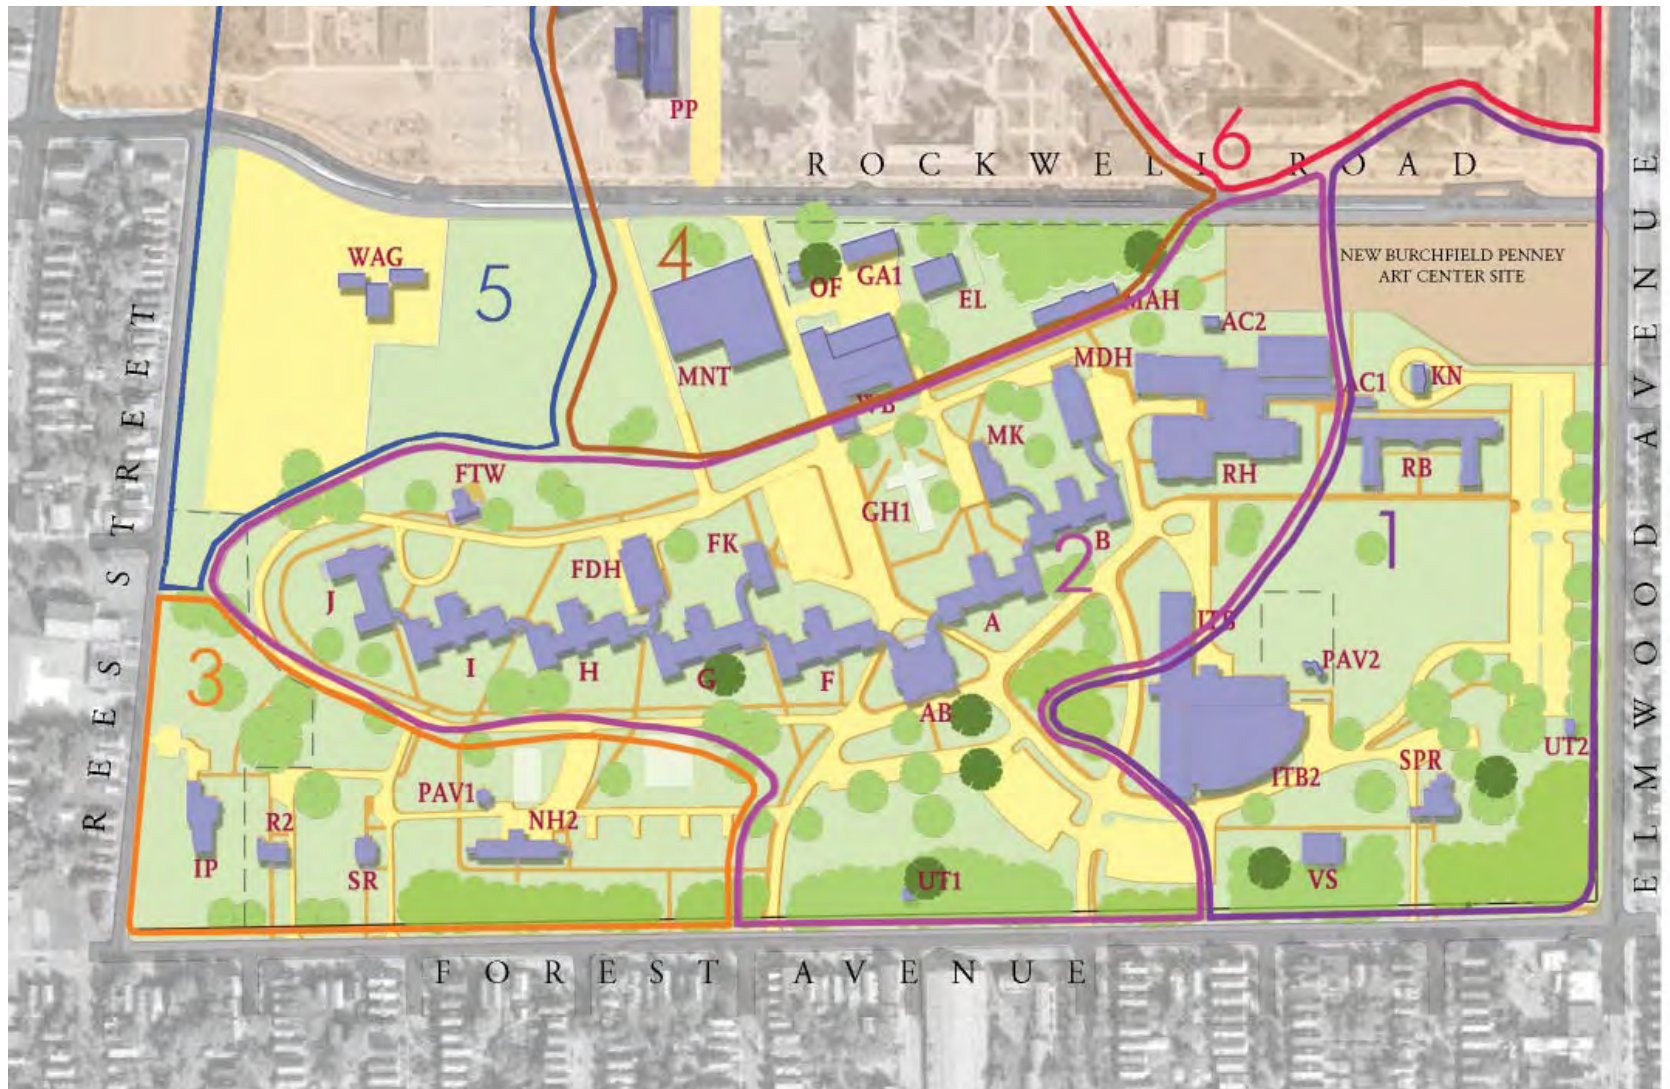
2008 Landscape Units Diagram

The landscape unit boundaries are defined during the period of time when the Richardson Olmsted Complex landscape was in its as-built condition in the early 20th century. Each of these areas is represented by color unit lines and numbers on the *Landscape Units Diagram*. The six landscape units for the Richardson Olmsted Complex are:

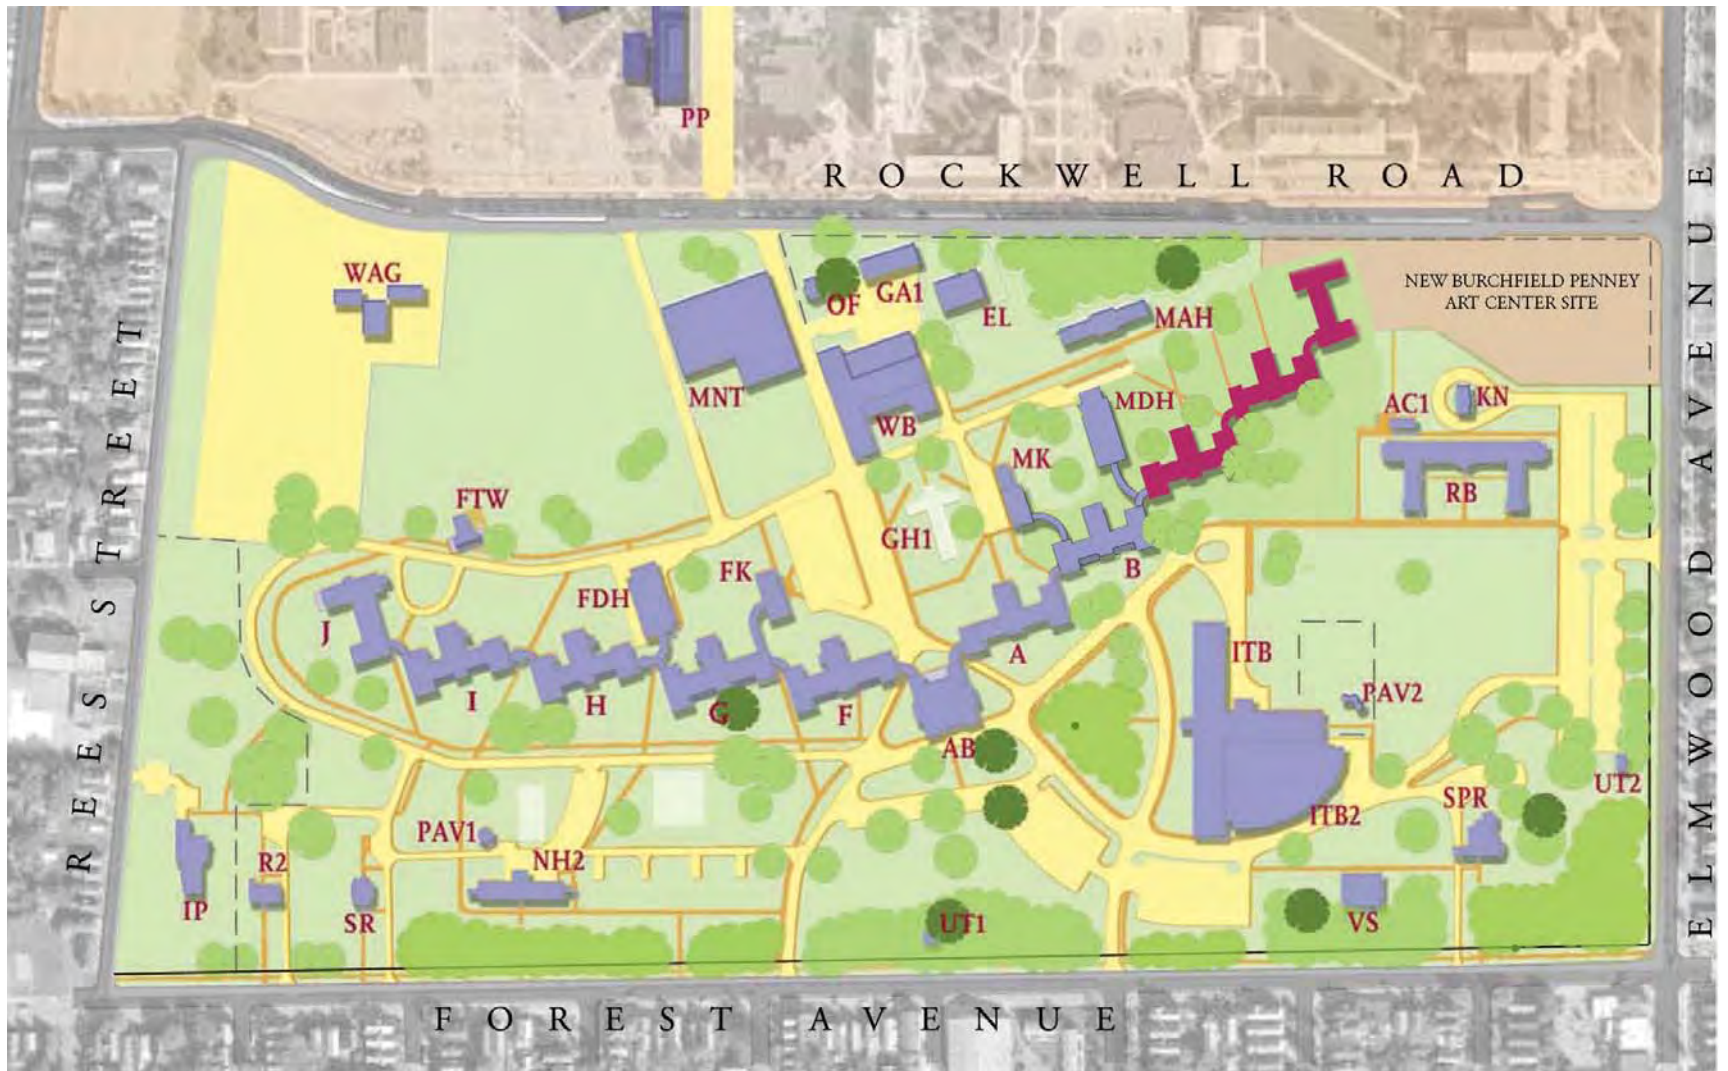
East Men's Wards Footprint Study

As site alternatives are explored, the potential of reconstructing the lost architecture of the Richardson Olmsted Complex east wing may be considered. Constructing a building on the footprints of the lost male wards could recapture former spatial definition while adding cohesion to both architecture and landscape, and providing additional building space and a boundary between hospital uses to the south and service uses or potential growth to the north.

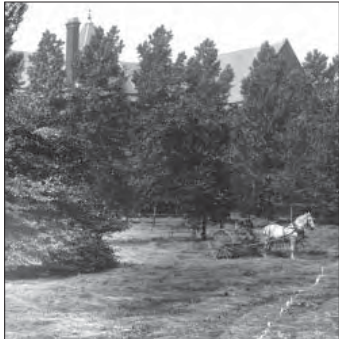
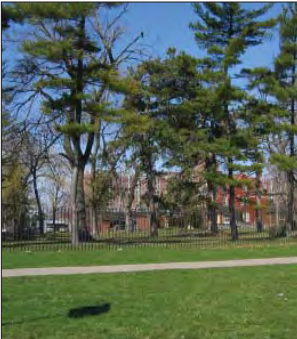
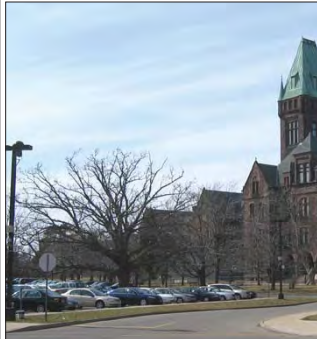
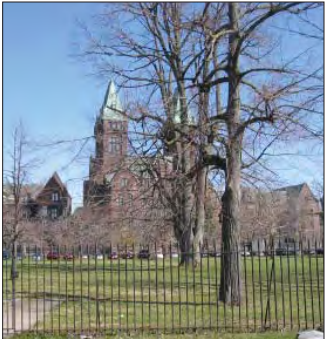
<p><i>Historic character defined by prolific plantings</i></p> <p><i>Vegetation created a pastoral quality in north farmlands</i></p> <p><i>Partial remnant grove in southeast corner</i></p> <p><i>Iconic swamp white oak south of Administration Building</i></p> <p><i>Witness ash tree (in rear) at Forest Avenue frontage</i></p> <p><i>Vegetation in decline</i></p>

Feature	Description	Significance	Condition	Integrity	Deficiencies	Recommendation
	Vegetation	Masses of trees and shrubs were an important element in the historic character of the hospital landscape, helping create a park-like setting and framing scenic landscape views. Today, few masses remain. Overall site vegetation is characterized by open turf interspersed with tree and shrub plantings and non-continuous rows planted along street edges.	Contributing	Fair	Moderate/ Low	Vegetation is less prolific than it was historically and distinct vegetation effect is no longer evident. Many trees are in decline and require care to promote health into the future. New construction has contributed to the natural decline of trees by compacting surrounding soil and root zones. Much of the complimentary open lawn spaces have been paved for surface parking.	Preserve and provide care for existing historic trees. Preserve and maintain specific iconic trees. Renew lost vegetation patterns, including street tree rows. Renew open lawn areas. Undertake preservation and stabilization efforts at greenhouse foundation, which is a remnant of former horticultural activities. Use sensitive design in all future construction to avoid impacts to historic trees and limit use of heavy machinery and soil compaction.

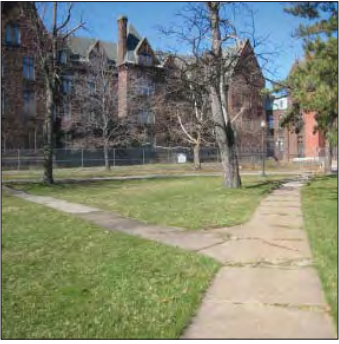
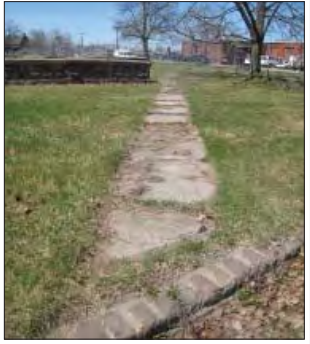
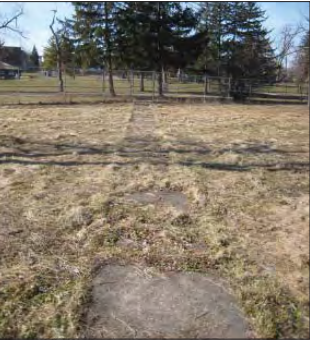
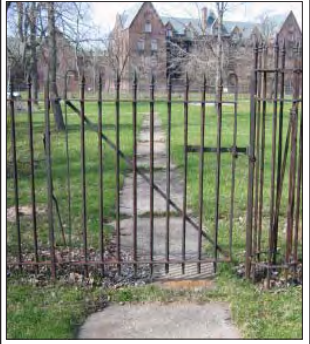
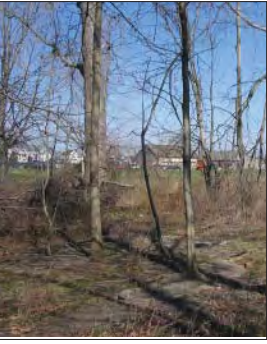
<i>Concrete walk to patient ward</i>	<i>Existing concrete walks connecting to drive</i>	<i>Remnant concrete paver path at greenhouse foundation</i>	<i>Partial path remnant with overgrown turf</i>	<i>Remnant concrete path with iron pedestrian gate</i>	<i>Partial flagstone walk remnant</i>

Feature	Description	Significance	Condition	Integrity	Deficiencies	Recommendation
	Historic Pedestrian Paths	Network of pedestrian paths was important in the historic landscape. Concrete paths provided convenient and scenic walks for patients. A number of flagstone paths were constructed as entry walkways connecting the main system of pedestrian paths with nearby buildings. The paths, measuring approximately 3 to 4 feet in width, helped define the unique historic character of the asylum grounds.	Contributing	Poor	Low	While historically concrete and flagstone paths formed a continuous network through the southern half of the site, today, portions of paths and entire paths are missing. With regard to the flagstone paths, minimal remnants remain.	Preserve remaining historic pedestrian paths; repair as needed and reconstruct missing sections. Remnant openings in the perimeter iron fence should be preserved as vestiges of the former circulation features and patterns. Future changes in pedestrian paths should be designed and laid out in a way that is compatible with the historic landscape character. Graceful curves and framed views should be used to create an integrated path system.

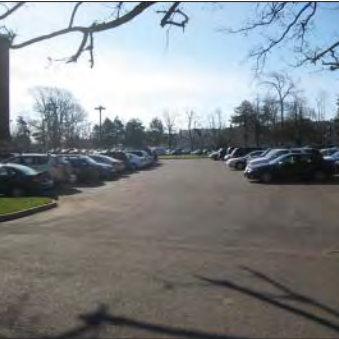
<p><i>First site parking lot constructed in 1930</i></p>

Feature	Description	Significance	Condition	Integrity	Deficiencies	Recommendation
	Parking Lots	A large portion of the Richardson Olmsted Complex landscape is utilized for surface parking with expansive areas of asphalt defining the foreground between the main building complex and Forest Avenue. Additional parking lots are located east of the main building complex, including a long, rectangular lot that defines much of the Elmwood Avenue frontage.	Non-Contributing	Fair	Low	Expansive areas of asphalt impact the historic scenic, park-like character of the asylum landscape and limit the amount of space available for site vegetation.	Existing parking should be relocated out of Landscape Unit 2 and relocated to be less visually obtrusive. Future additions to site parking should be visually recessive and should not be located within the primary vistas along Forest Avenue; specifically, surface parking should not be placed within Landscape Units 1, 2, or 3.

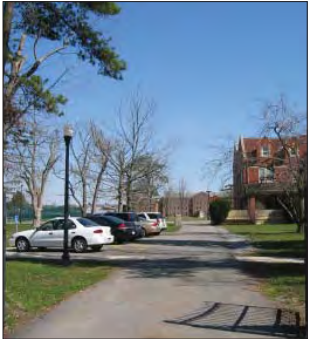
<p><i>Parking defines much of the southern landscape character</i></p>

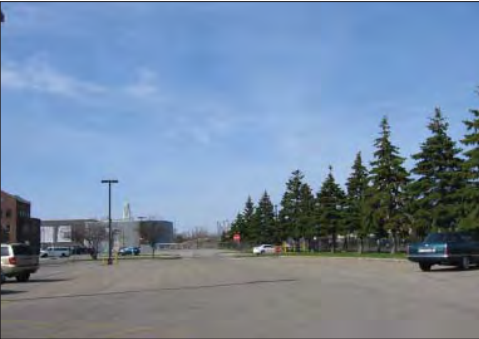
<p><i>Parking lot constructed alongside a former carriage drive</i></p>

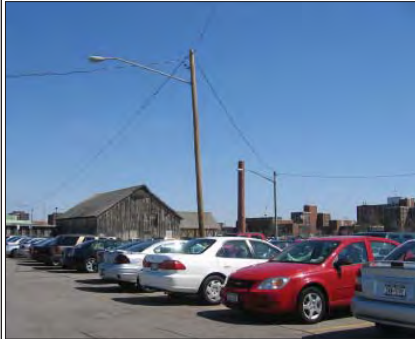
<p><i>Large parking lot defines the Elmwood Avenue frontage</i></p>

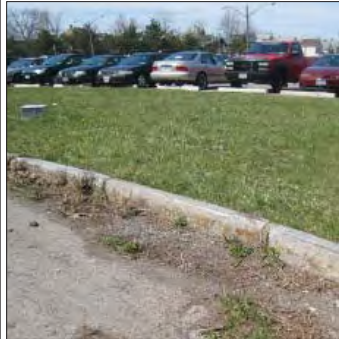
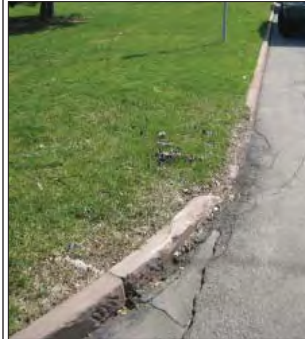
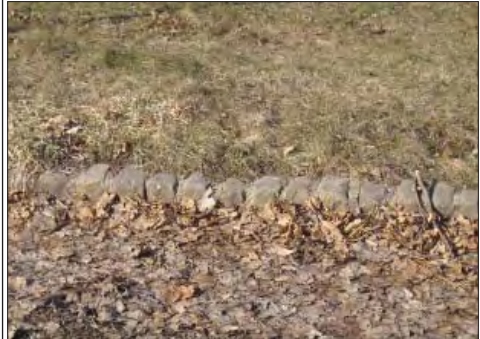
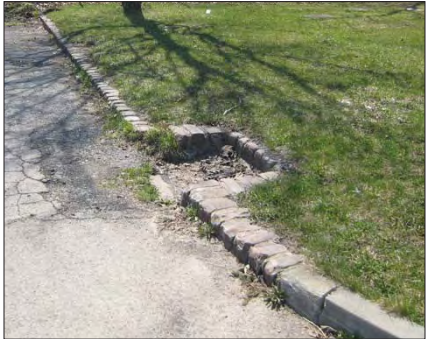
<i>Deteriorated concrete curbs</i>	<i>Granite curbs</i>	<i>Brownstone curbs along Rees Street</i>	<i>Remnant stone & mortar curbs</i>	<i>Remnant stone & mortar curbs intersect with newer concrete curbs</i>

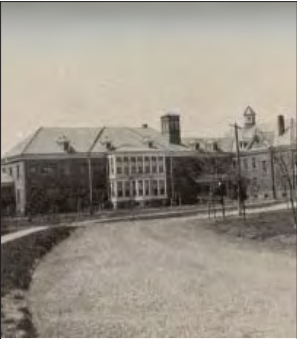
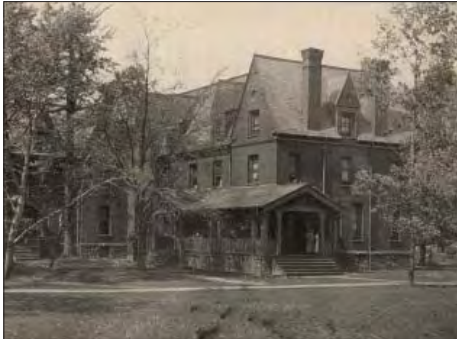
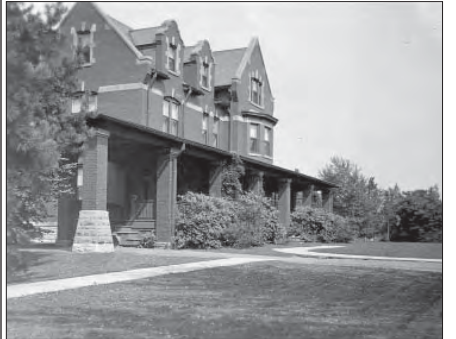
<i>Curving drives helped define site entry landscape</i>	<i>Eastern half of original curved entry drive from Forest Avenue</i>	<i>Former Elmwood Complex entry drive and walk</i>	<i>Simple walks provided routes between buildings and primary circulation</i>	<i>Walks and drives connected staff homes directly with public streets</i>

Feature	Description	Significance	Condition	Integrity	Deficiencies	Recommendation			
	Future Circulation Features	Additions and alterations to the site circulation system, including the overall character and patterns as well as individual features, have been constructed to address shifting demands of site use and functionality. Consideration for retaining the historic character of site circulation and the impact circulation features have on the overall landscape character is not readily evident.	Non-Contributing	N/A	N/A	N/A	Future changes in the site circulation system should be designed and laid out in a way that is compatible with the historic landscape character. Specifically, future circulation features and alterations to existing circulation features should be designed in the Olmsted Vaux style, utilizing subtle curves to define views of the surrounding landscape. Parking lots should be visually recessive and placed outside Landscape Units 1, 2, and 3.

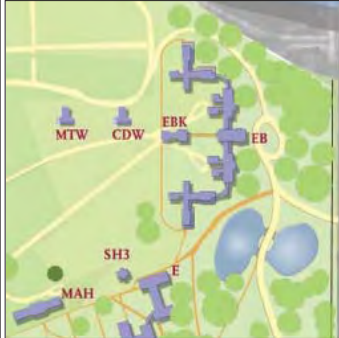
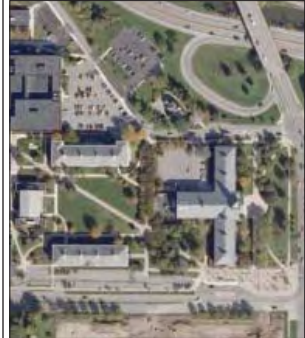
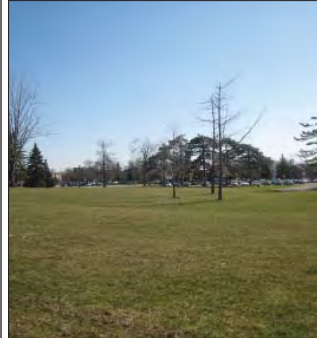
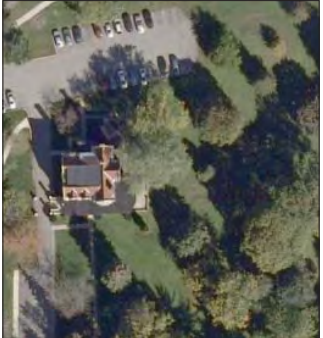
<i>Historic view of constructed pond</i>	<i>Plan view of Elmwood Complex entry with pond</i>	<i>Contemporary aerial- site of former Elmwood Complex</i>	<i>Open area east of Strozzi Building</i>	<i>Plan view of residence and pool</i>	<i>Contemporary aerial- site of pool</i>

Feature	Description	Significance	Condition	Integrity	Deficiencies	Recommendation
Elmwood Complex Entry Landscape Pond & Superintendent's Residence Pool	Large pond with a bridge crossing and elm tree plantings constructed as part of the Elmwood Complex entry landscape – removed circa 1927-1929 when the northern lands were transferred to the City of Buffalo and the Elmwood Complex demolished. A pool was constructed as part of a staff residence at southeast site corner and has since been removed.	N/A	Non-extant	N/A	No interpretation of these character-defining features has been undertaken.	Recapture former pond in new location, either east of the Strozzi Building to separate active hospital use from new Art Center or in a low-lying area to serve as storm water retention. Interpret residence pool.

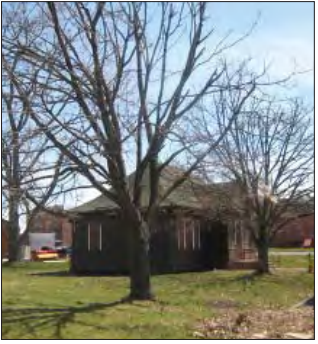
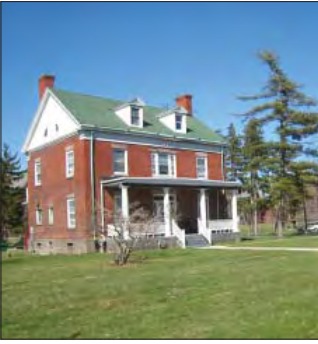
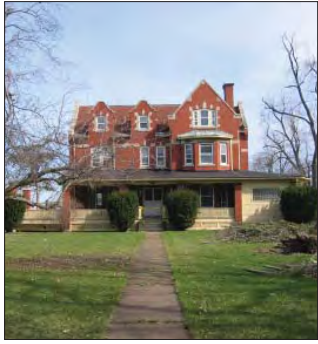
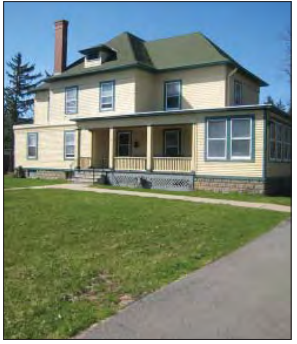
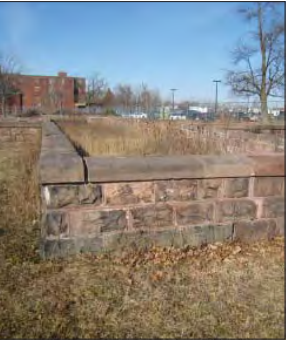
<i>Female Tuberculosis Ward</i>	<i>Small Office Building</i>	<i>Steward's Residence</i>	<i>Superintendent's Residence</i>	<i>Staff Residence</i>	<i>Greenhouse Foundation</i>

Feature	Description	Significance	Condition	Integrity	Deficiencies	Recommendation					
	Female Tuberculosis Ward Small Office Steward's Residence Superintendent's Residence Staff Residence Greenhouse Foundation Summerhouses	Small-scale structures are placed throughout the hospital landscape, including small one-story wood-frame buildings and larger two-story former staff housing. While some are vacant with boarded up windows, others are used by the Buffalo Psychiatric Center. The style and setting of these features reveal a sense of the historic landscape character. The greenhouse foundation serves as an interpretive feature of the historical horticultural activities of the hospital.	Contributing	Fair/Good	Moderate to N/A	Some deterioration present in vacant structures and volunteer, overgrown vegetation alters setting in the landscape. Pastoral setting of some altered with construction of buildings, roads, and parking lots. Staff Residence at southwest corner is somewhat isolated from the remainder of the site.	Stabilize to prevent further deterioration. Promote continued use of structures currently used by the hospital. Repoint greenhouse mortar with mortar that matches historic color and composition.
